P54.21-2652-09

☒ ☒	Remove/install		
1.1  <b>AD</b>	Temporarily store basic data from front central operating unit (A40/9) in STAR DIAGNOSIS  Connect STAR DIAGNOSIS and read out fault memory	When replacing the front central operating unit (A40/9).  <b>i</b> <b>Installation:</b> Transfer the temporarily stored basic data to the new front central operating unit (A40/9).	  <b>AD00.00-P-2000-04A</b>
2	Switch off ignition and withdraw transmitter key or Keyless Go start/stop button from the EIS [EZS] control unit	<b>i</b> Keyless Go start/stop button only for vehicles with code (889) Keyless Go.	
3	Remove turn/push control		<b>AR54.21-P-0501SX</b>

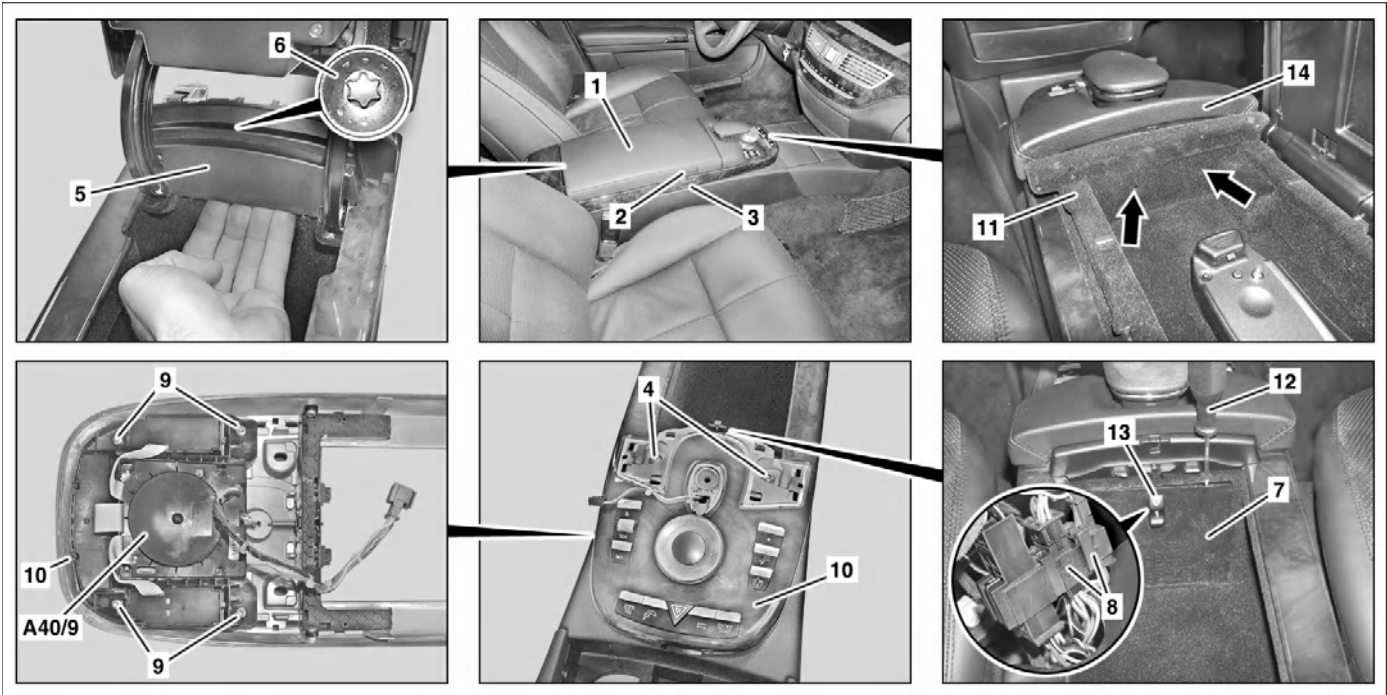
| 1 Armrest | 7 Maintenance flap (without code (582) Rear air conditioning) | 12 Screwdriver |
| 2 Release button | 8 Electrical connectors | 13 Adjustment wheel (without code (582) Rear air conditioner) |
| 3 Unlock button (without code (582) Rear air conditioning) | 9 Bolts | 14 Cover |
| 4 Bolts | 10 Trim | A40/9 Front central operating unit |
| 5 Hinge cover | 11 Telephone or stowage compartment | |
| 6 Screw | | |

4.1	Press release button (3) and lift armrest (1) towards the rear	On vehicles without code (582) Rear air conditioning	
4.2	Press release button (2) and open telephone or stowage compartment (11)	On vehicles with code (582) Rear air conditioning	
5	Unlock telephone or stowage compartment (11) using suitable tools through the openings (arrows) and lift towards the rear	On vehicles with code (582) Rear air conditioning	
6	Unclip cover (14) from center console	<b>☒</b>	<b>*110589035900</b>
7	Close off stowage compartment ventilation via adjustment wheel (13) and unclip maintenance flap (7) using a suitable screwdriver (12)	On vehicles without code (582) Rear air conditioning	
8	Expose wiring harness in center console and separate electrical connectors (8)	<b>i</b> The number of electrical connectors (8) varies depending on the vehicle equipment.	
9	Remove trim at rear of center console		<b>AR68.20-P-5169SX</b>

10	Unclip hinge cover (5)		
11	Remove bolts (4, 6)		
12.1	Lift trim (10) at front, guide it backwards out of center console together with telephone or stowage compartment (11) and remove	On vehicles without code (386) Preinstallation for telephone "Handy", UPCI system or without code (388) Telephone "Handy", UPCI system

<b>i</b> <b>Installation:</b> Ensure that the wiring harness of the front central operating unit (A40/9) is correctly routed.	
12.2	Lift trim (10) until the underside of the front central operating unit (A40/9) is accessible	On vehicles with code (386) Preinstallation for telephone "Handy", UPCI system or with code (388) Telephone "Handy", UPCI system <b>i</b> <b>Installation:</b> Ensure that the wiring harness of the front central operating unit (A40/9) is correctly routed.	
13

Remove bolts (9) and remove front central operating unit (A40/9) from trim (10) Information on preventing damage to electronic components due to electrostatic discharge		AH54.00-P-0001-01A
14	Install in the reverse order
