MODEL 216.3, 221.0 /1

P82.60-5390-09

N93/1 Audio tuner control unit

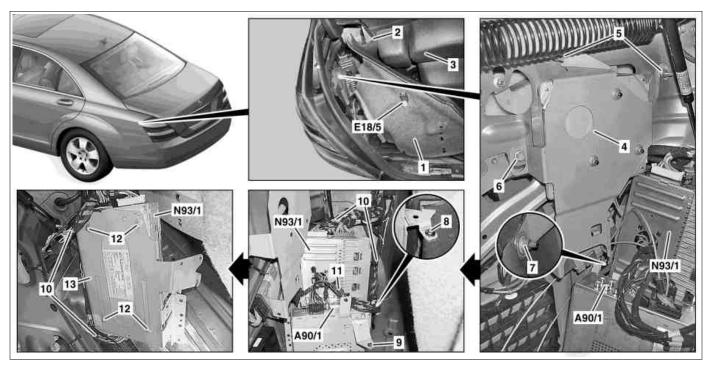
Shown on model 221

- Side trunk paneling 1
- 2 Hinge lever passage frame
- 3 Trunk floor paneling
- Bracket

(with code (218) Backup camera or code (390 to 396) Linguatronic or code (529) HIGH Class Japan or code (813) Voice control system (VCS [SBS]))

- 5 Nuts (with code (218) Backup camera or code (390 to 396) Linguatronic or code (529) HIGH Class Japan or code (813) Voice control system (VCS [SBS]))
- Screw 6 (with code (218) Backup camera or code (390 to 396) Linguatronic or code (529) HIGH Class Japan or code (813) Voice control system (VCS [SBS]))
- Nut

- 8 Screw
- 9 Bolt (for code (863) Digital/analog TV tuner)
 - Wiring harness
- Wiring harness (for code (863) 11
- Digital/analog TV tuner)
- Nuts 12

- Bracket 13
- A90/1 TV combination tuner (analog/ digital) (for code (863) Digital/ analog TV tuner)

Left luggage compartment lamp E18/5

区区	Remove/install		
(1)	Information on preventing damage to electronic components due to electrostatic discharge		AH54.00-P-0001-01A
1	Temporarily store basic data of audio tuner control unit (N93/1) in STAR DIAGNOSIS	When replacing audio tuner control unit (N93/1). i Installation: Copy temporarily stored basic data to new audio tuner control unit (N93/1).	
⊯ AD	Connect STAR DIAGNOSIS and read out fault memory		AD00.00-P-2000-04A
2	Switch off ignition and withdraw transmitter key or Keyless Go start/stop button from the EIS [EZS] control unit	Keyless Go start/stop button only for vehicles with code (889) Keyless Go.	
3	Remove spare tire well paneling	On model 216	AR68.30-P-4600SX
4	Release trim at side in luggage compartment (1) and swivel to one side until the audio tuner control unit (N93/1) is accessible		AR68.30-P-4600SX
5	Loosen nuts (5) and bolt (6), detach bracket (4) and place to one side with lines connected	For vehicles with code (218) Backup camera or with code (390 up to 396) Linguatronic or with code (529) HIGH Class Japan or with code (813) Voice control system (VCS [SBS])

6	Remove nut (7)		
_	1.1.1.(0)

8	Unscrew bolt (9)	For vehicles with code (863) Digital/analog TV tuner	
9	Raise bracket (13), place to one side and detach electrical connectors on audio tuner control unit (N93/1)	Do not twist wiring harness (11) (for code (863) Digital/analog TV tuner) and wiring harness (10) too far as otherwise the fiber optic cable may be damaged.	
(1)	Notes on avoiding damage to fiber optic cables during repair work		AH82.60-P-0001-05AK
10	Undo nuts (12) and remove audio tuner control unit (N93/1) from bracket (13)		
11	Install in the reverse order
