MODEL 216, 221.0 /1

with CODE (409) Left/right front multicontour seats

with CODE (432) Left and right dynamic multicontour seat

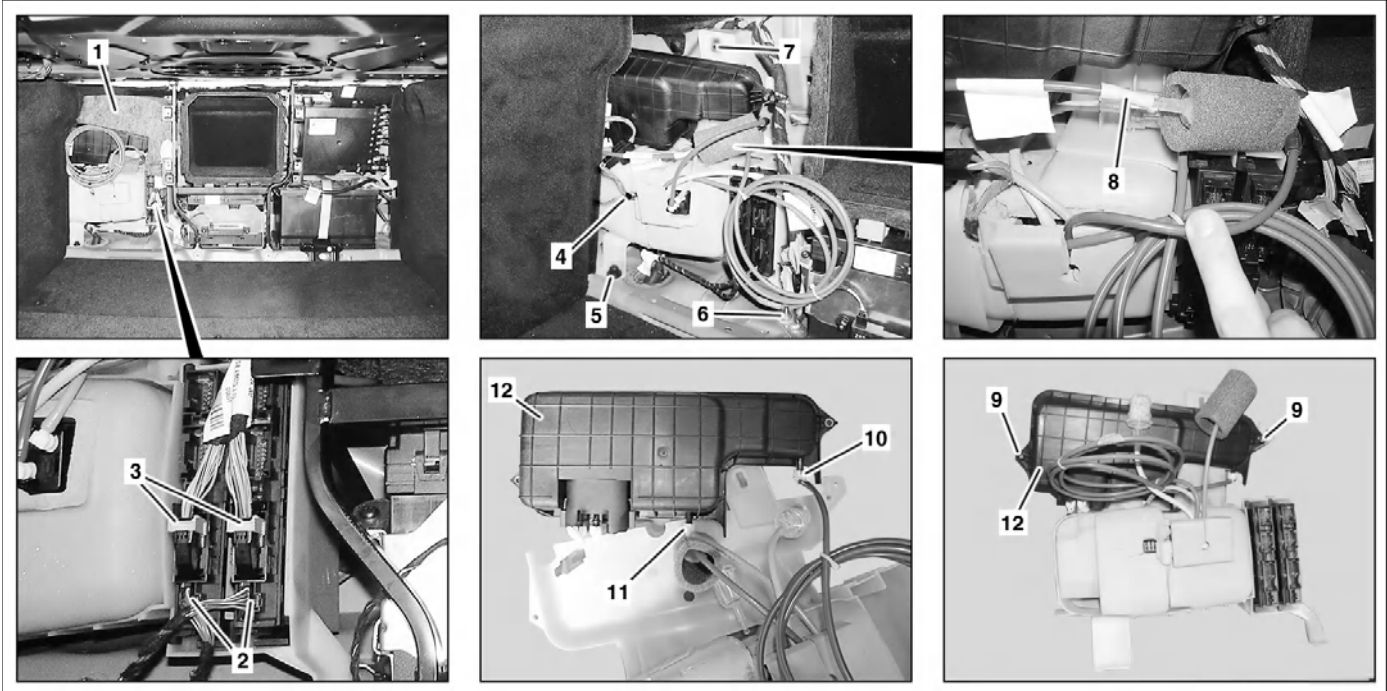
P91.25-2332-09

Shown on vehicle with code (406) Rear multicontour seats

| 1 | Insulating material | 4 | Electrical connector | 9 | Screw |
| 2 | Electrical connectors (with code (406) Rear multicontour seats) | 5 | Nut | 10 | Pneumatic connector |
| 3 | Electrical connectors (with code (406) Rear multicontour seats) | 6 | Nut | 11 | Pneumatic connector |
| | | 7 | Nut | 12 | Overpressure reservoir |
| | | 8 | Pneumatic line | | |

Remove/install		
1	Remove rear shelf reinforcement	Only on model 221.	AR64.10-P-1200SX
2	Switch off ignition and remove transmitter key or Keyless-Go start/stop button from EZS control unit

Keyless-Go start/stop button only on vehicles with code (889) Keyless-Go.	
3	Remove insulating material (1) and unscrew nuts (5, 6, 7)		
4	Disconnect electrical connectors (2, 3)	On vehicles with code (406) Rear multicontour seats.	
5	Disconnect electrical connector (4) and pneumatic line (8)		
6	Remove overpressure reservoir (12) with bracket out of vehicle and detach from bracket		
7	Install in the reverse order
