P64.10-2113-09

Rear wall, rear shelf

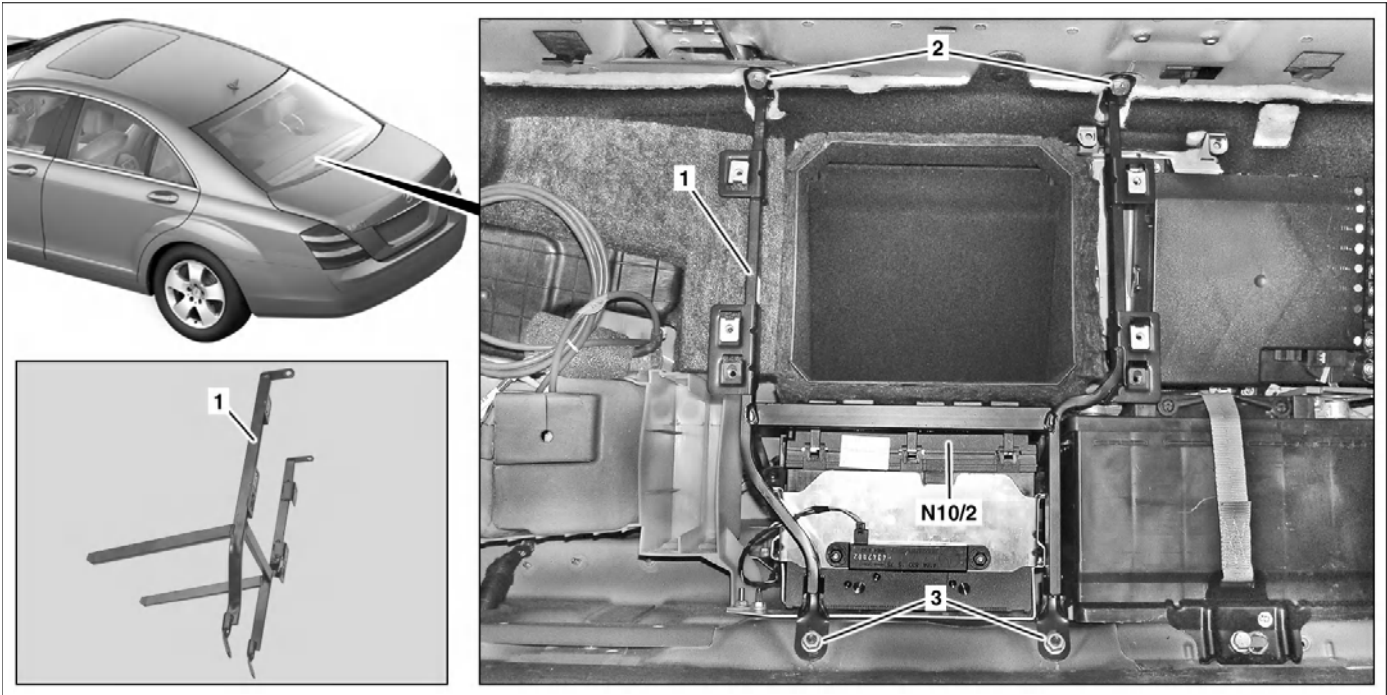
Shown on model 221

- 1 Reinforcement
- 2 Bolts

- 3 Nuts

- N10/2 Rear SAM control unit with fuse and relay module

Remove/install		
1	Remove trunk paneling at top	Vehicles without code (Z07) Top protection Vehicles with code (Z07) Top protection	AR68.30-P-4600SX AR68.30-P-4600SXS
2	Unscrew screws (2) and nuts (3)

<b>Installation:</b> Tighten reinforcement (1) first with bolts (2) at top, then with nuts (3) at bottom to prevent distortions and damage to the body.	*BA64.10-P-1001-01A
3	Guide reinforcement (1) out below rear shelf, pivot downward and remove from threaded studs

This motion sequence is required, otherwise the side struts of the reinforcement (1) and the electrical lines next to the rear SAM control module with fuse and relay module (N10/2) can be damaged.	
4	Install in the reverse order
