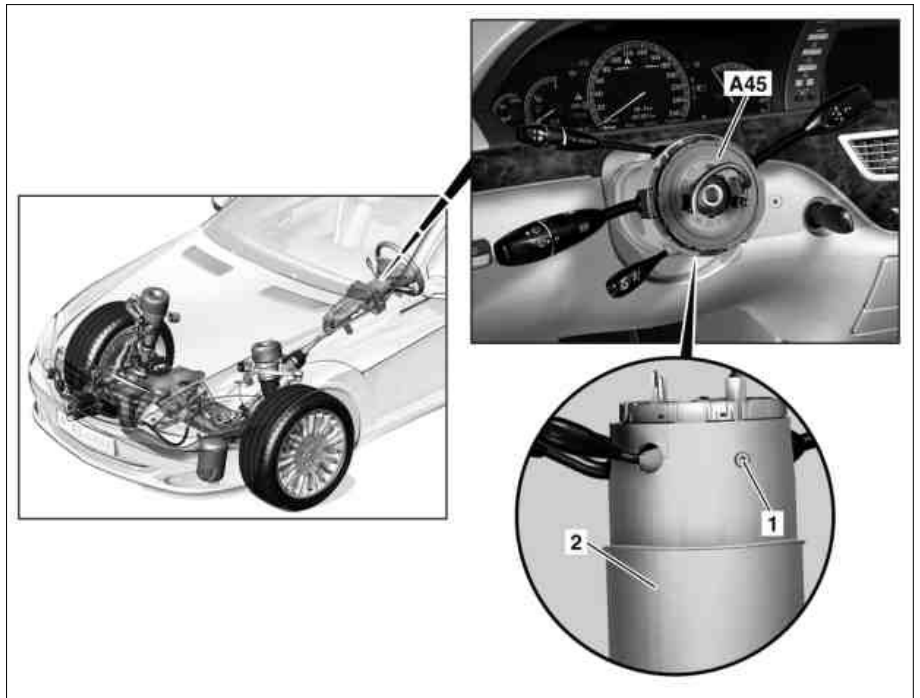
P54.25-4809-06

- 1 Bolt
- 2 Steering column switch module

A45 Fanfare horns and airbag clock spring contact

- 1 Unscrew bolt (1).

Bolt (1) is secured to prevent it from falling out.
- 2 Disconnect steering column switch module (2) complete with fanfare horns and airbag clock spring contact (A45) from jacket tube.
