MODEL 221.0 /1

with CODE (409) Left/right front multicontour seat

with CODE (432) Left and right dynamic multicontour seat

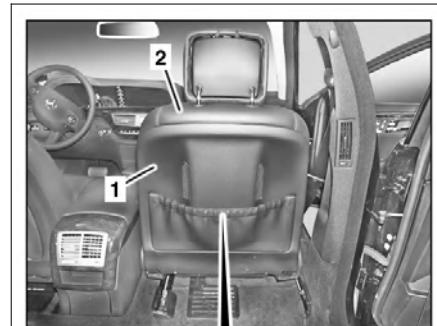
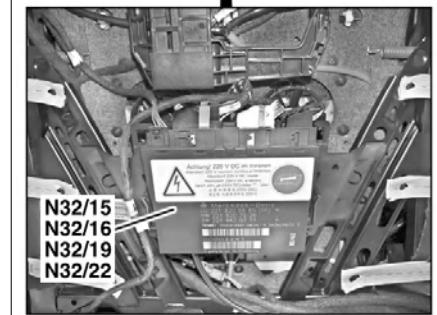
P91.25-2334-03

1 Tensioning element

2 Front seat

N32/15 Left front multicontour backrest control unit

N32/16 Right front multicontour backrest control unit

N32/19 Left front dynamic seat control unit

N32/22 Right front dynamic seat control unit

Remove/install		
	Information on preventing damage to electronic components due to electrostatic discharge		AH54.00-P-0001-01A
1	Switch ignition off and remove transmitter key or Keyless Go start/stop button from EIS [EZS] control unit	Keyless Go start/stop button only in vehicles with code (889) Keyless Go.	
2	Remove seat-back lining (1) from backrest of left or right front seat (2)		
3	Disconnect electrical connectors and remove left front multicontour backrest control unit (N32/15) or left front dynamic seat control unit (N32/19) and right front multicontour backrest control unit (N32/16) or right front dynamic seat control unit (N32/22)		
4	Install in the reverse order
