MODEL 222.0/1

3.7.13 Remove cover and trailer hitch switch

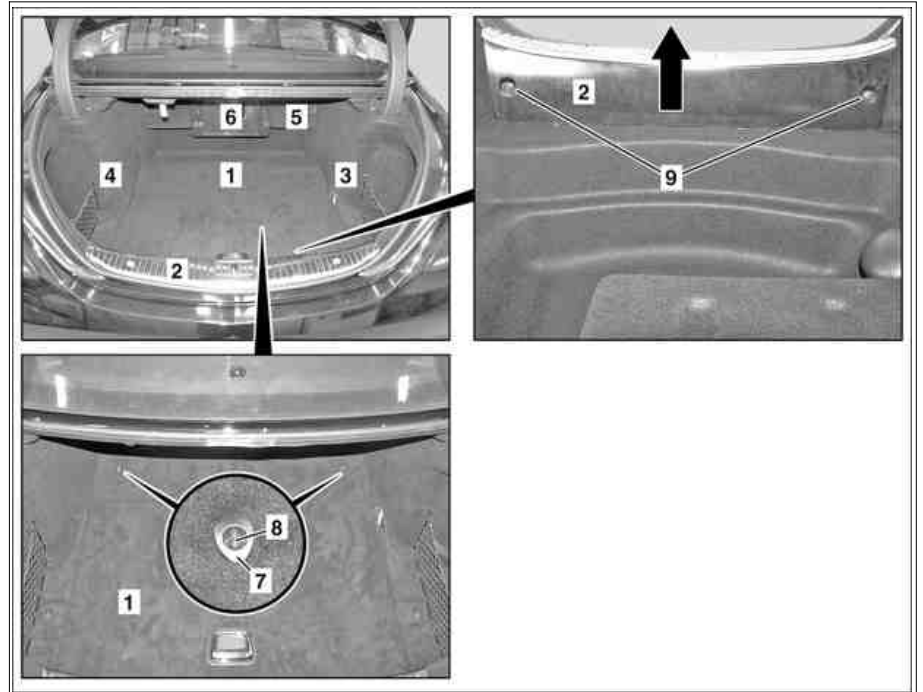
P68.30-3706-06

Shown on vehicles with CODE 282 (Ski bag)

- 1 Trunk floor lining
- 2 Rear center section paneling
- 3 Right paneling
- 4 Left paneling
- 5 Dividing wall paneling
- 6 Through-loading
- 7 Bracket
- 8 Screw
- 9 Expansion rivet

4.1	Remove trunk floor lining (1)	When removing right paneling (3), left paneling (4). When removing partition wall paneling (5), on vehicles with hybrid drive.

4.2	Lift trunk floor lining (1)	When removing paneling rear center section (2), slightly lift trunk floor lining (1) and hook into edge guard on trunk cutout.	
5	Remove expansion rivet (9) and unclip paneling rear center section (2) upward

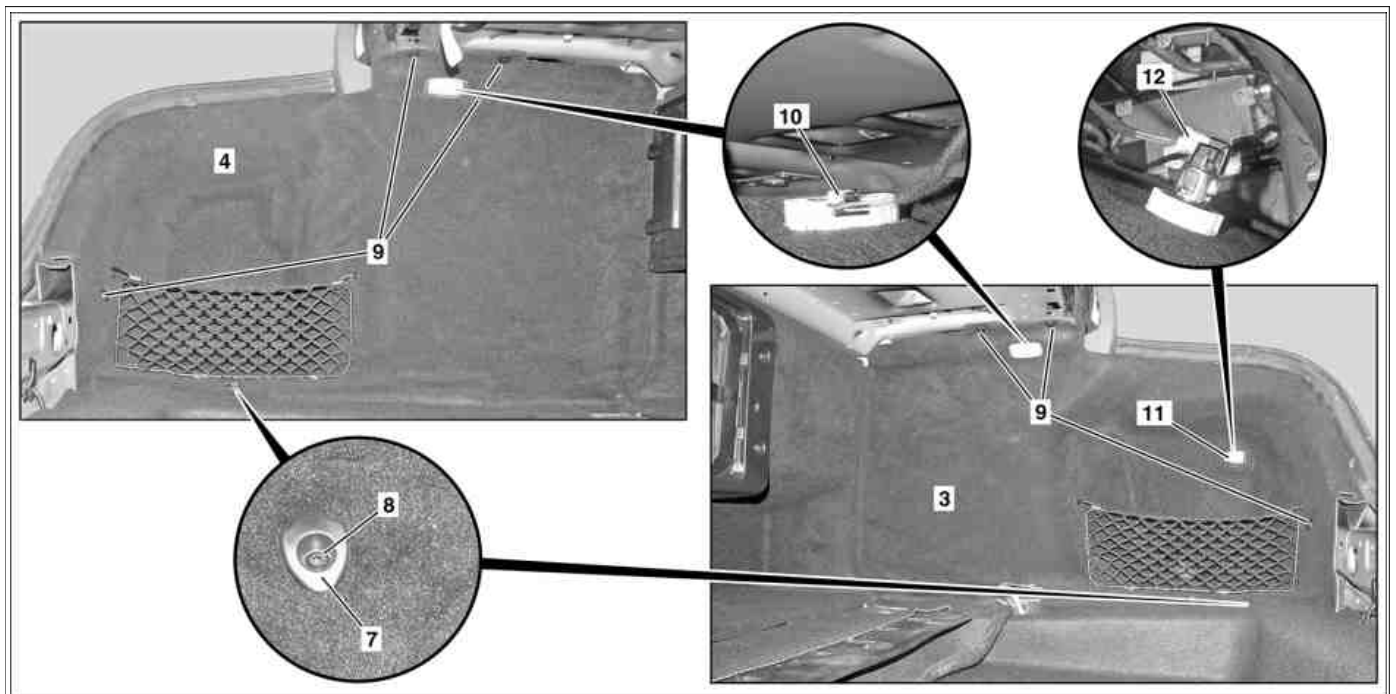
P68.30-3707-09

- 3 Right paneling
- 4 Left paneling
- 7 Bracket
- 8 Screw

- 9 Expansion rivet
- 10 Electrical connector
- 11 12-V socket
- 12 Electrical connector

6.2	Unscrew bolts (13) from through-loading facility (6)	On vehicles with CODE 282 (Ski bag) or with CODE 308 (cooling compartment in rear)	
7	Remove through-loading facility (6)	On vehicles with CODE 282 (Ski bag) or with CODE 308 (cooling compartment in rear)	
8	Remove dividing wall paneling (5)		
9	Remove expansion rivet (9) from left paneling (4)	i On vehicles with CODE 811 (Advanced sound system) only two expansion rivets (9) are present.	
10	Detach left paneling (4) and disconnect electrical connector (10)		
11	Remove left paneling (4)		
12	Remove expansion rivet (9) from right paneling (3)		
13	Unclip cover with trailer hitch switch	MODEL 222.0/1 with CODE 550 (Trailer coupling)	
14	Disconnect electrical connectors from trailer hitch switch	MODEL 222.0/1 with CODE 550 (Trailer coupling)	
15	Detach right paneling (3) and disconnect electrical connectors (10, 12)		
16	Remove right paneling (3)

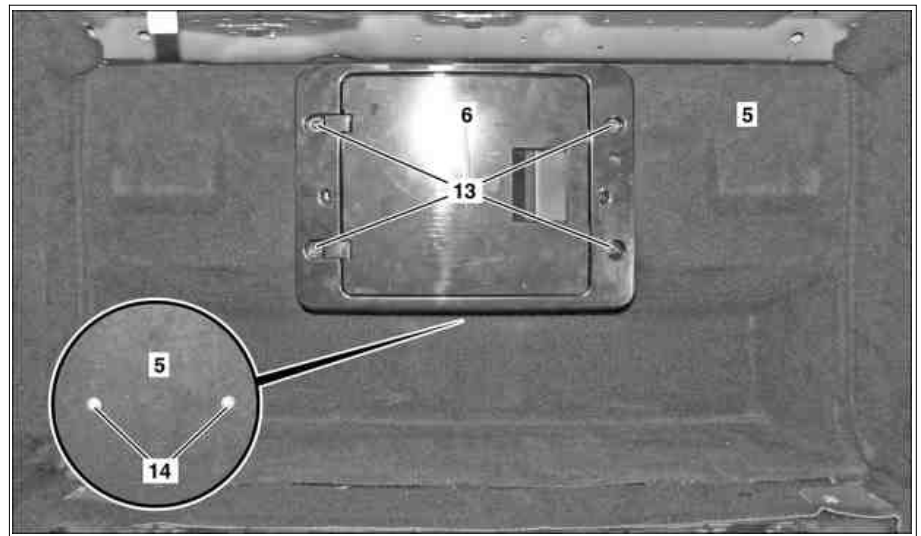
P68.30-3708-05

Shown on vehicles with CODE 282 (Ski bag)

- 5 Dividing wall paneling
- 6 Through-loading
- 13 Screw
- 14 Expansion rivet

6.1	Remove expansion rivet (14) from partition wall paneling (5)	On vehicles without CODE 282 (Ski bag) or without CODE 308 (cooling compartment in rear)
