#### Model 222.0/1

#### **Modification notes**

24.08.2017 Remove speaker cover and seat belt guide/trim.

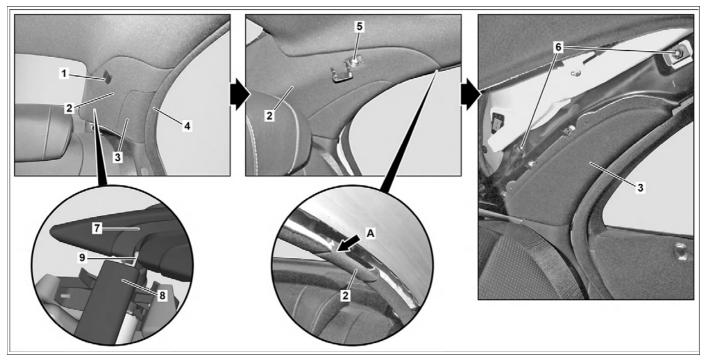
P68.30-3684-09

## Shown on model 222.1 with code Z07 (Top protection)

- 1 Cover
- 2 C-pillar paneling top section
- 3 C-pillar paneling bottom section
- 4 Edge guard
- 5 Nut

- 6 Buckle clamp
- 7 Guide rail
- 8 Roller sun blind
- 9 Pin

Note on functional reliability of windowbag		AH91.60-P-0693-01A
XX	Remove/install		
1	Remove edge guard (4) in area of C-pillar trim		
2	(2, 3) Unclip cover (1)

3.1	Unscrew nut (5)	Model 222.0/1	
3.1	Unscrew nut (5)	except code Z07 (Top protection)	
		Nml Nut/screw, trim bracket to C-pillar	*BA68.30-P-1002-01E
3.2	Remove screw (14) under cover (1)	Model 222.0/1 with code Z07 (Top protection)	
		Nm Nut/screw, trim bracket to C-pillar	*BA68.30-P-1002-01E
4	Unclip guide rail (7) from C-pillar paneling top section (2)	Model 222.0/1	
		with code 540 (Electric sunblind for rear window) except code Z07 (Top protection)	
		(arrow B), turn 90° and unclip guide rail (7) from top downward. Guide rail (7) is hooked	
		into C-pillar paneling top section (2) at bottom.	
		li Installation: Ensure that pin (9) on roller blind (8) is seated correctly in guide rail (7). Ensure that guide rail (7) is seated correctly.	
		S Extraction hook	*140589023300
5	Lever retainer (arrow A) of C-pillar trim upper section (2) over roof lining (10)		
6	from C-pillar trim upper section (2)	Model 222.0/1 with code Z07 (Top protection)  Slightly press in spring clip (13), guide rive

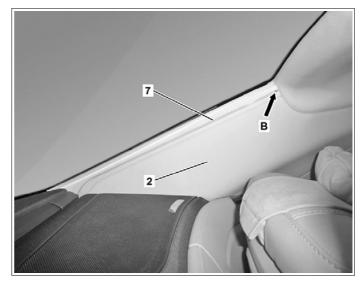
P68.30-3722-11

## Shown on model 222.1 without code Z07 (Highest protection)

- 2 C-pillar paneling top section
- 7 Guide rail

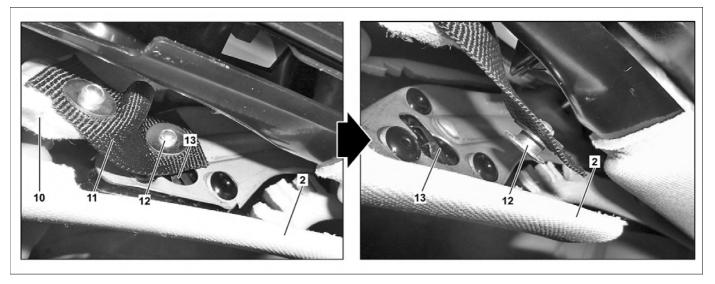
P68.30-3721-08

## Shown on model 222.1 with code Z07 (Top protection)

- 2 C-pillar paneling top section
- 10 Headliner
- 11 Check strap

- 12 Rivet
- 13 Spring clip

(12) together with check strap (11) out of opening.	
		Installation: Ensure that check strap (11) and rivet (12) are seated correctly.	
7	Unclip speaker cover (17) in upward direction		
8	Unclip seat belt guide trim element (15) and allow to hang down		
9	Unclip seat belt retractor cover (16)		
10	Unclip C-pillar paneling top section (2) along rear window		
11	Remove C-pillar paneling top section (2) in direction of travel		
12	Unscrew buckle clamps (6)	Model 222.0/1 except code Z07 (Top protection)  i Installation: Replace buckle clamps (6).	
13	Remove C-pillar trim lower section (3)	i Carefully swivel C-pillar trim lower section (3) toward front. Side trim in rear is connected via a pin with C-pillar trim lower section (3).  i Installation: Before assembly, install new strap buckles (6) on C-pillar trim lower section (3).	
14	Install in the reverse order

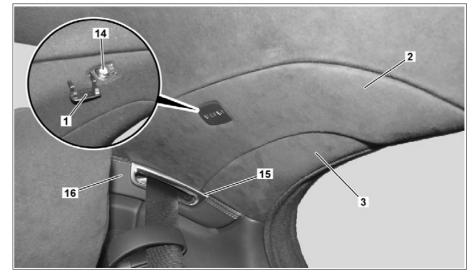
P68.30-4017-05

# Shown on model 222.1 with code Z07 (Top protection)

- 1 Cover
- 2 C-pillar paneling top section
- 3 C-pillar paneling bottom section
- 14 Screw
- 15 Seat belt guide trim element
- 16 Seat belt retractor cover

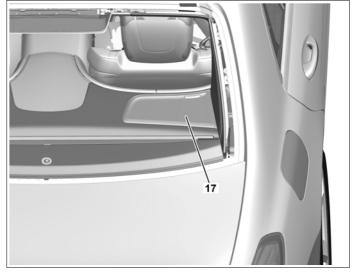
P82.62-4700-11

### 17 Speaker cover
