MODEL 222
with CODE P46 (Individual Entertainment in the rear)
without CODE 224 (First-Class rear compartment)

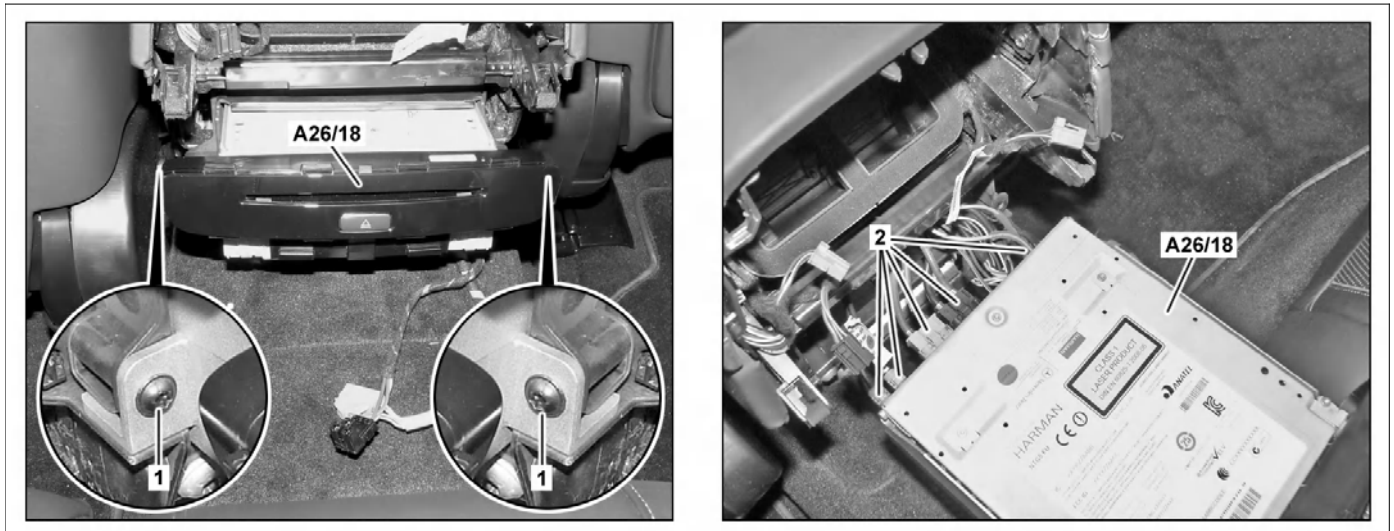
P82.60-9191-08

- 1 Screw
 2 Electrical connectors

A26/18 Rear entertainment controller unit

ⓘ	Notes on avoiding damage to optical fibers during repair work		AR82.60-P-0001-05AK
ⓘ	Information on preventing damage to electronic components due to electrostatic discharge		AR54.00-P-0001-01A
⊞ ⊞	Remove/install		
1	Connect Star Diagnosis and perform commissioning of Rear Seat Entertainment system controller unit (A26/18)	When replacing Rear Seat Entertainment system controller unit (A26/18).	
2	Switch off ignition and remove transmitter key from electronic ignition lock control unit		
3	Remove cover on center console	MODEL 222.0/1 with CODE P46 (Individual Entertainment in the rear) without CODE 224 (First-Class rear compartment)	AR68.20-P-2350LF
4	Remove bolts (1)		
5	Guide Rear Seat Entertainment system controller unit (A26/18) out of center console until electrical connectors (2) are accessible		
6	Separate electrical connectors (2)		
7	Remove Rear Seat Entertainment system controller unit (A26/18) from vehicle

8	Install in the reverse order
