Model 213, 238
 Model 222
 as of model year 2018

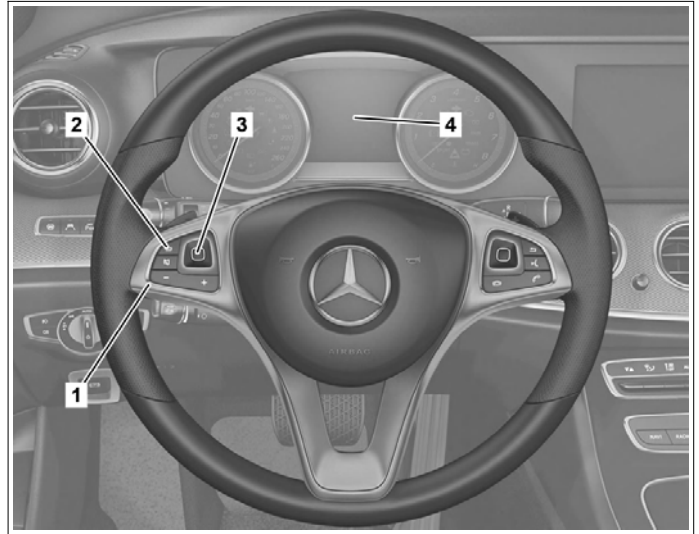
P00.20-2892-11

Shown on model 213

- 3 Finger navigation pad
- 4 Multifunction display

| | Dialing | | |
|---|---|--|---|
| 3 | Use swipe movements on the finger navigation pad (3) to select menu item "ASSYST PLUS" in the multifunction display (4) | | |
| 4 | Confirm selection of "ASSYST PLUS" by pressing on the finger navigation pad (3) | i The tabs are shown on the multifunction display (4): "Service data", "Full service", "Vehicle handover". | |

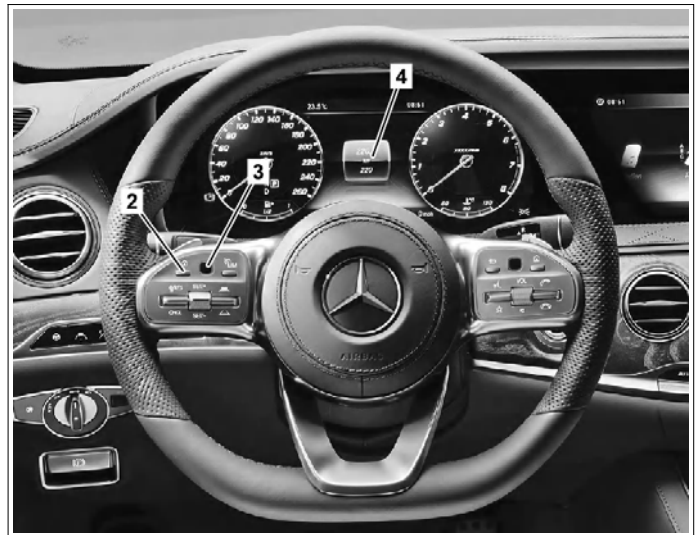
P00.20-2941-11

Shown on model 222.0 as of model year 2018

- 3 Finger navigation pad
- 4 Multifunction display
