Service Campaign Bulletin

Campaign No. 2022070004, August 2022

SUBJECT: **Model S-Class (217 and 222 platform)**
Model Year 2018 - 2021

Replace Braided Hose of Low-Pressure Fuel Line

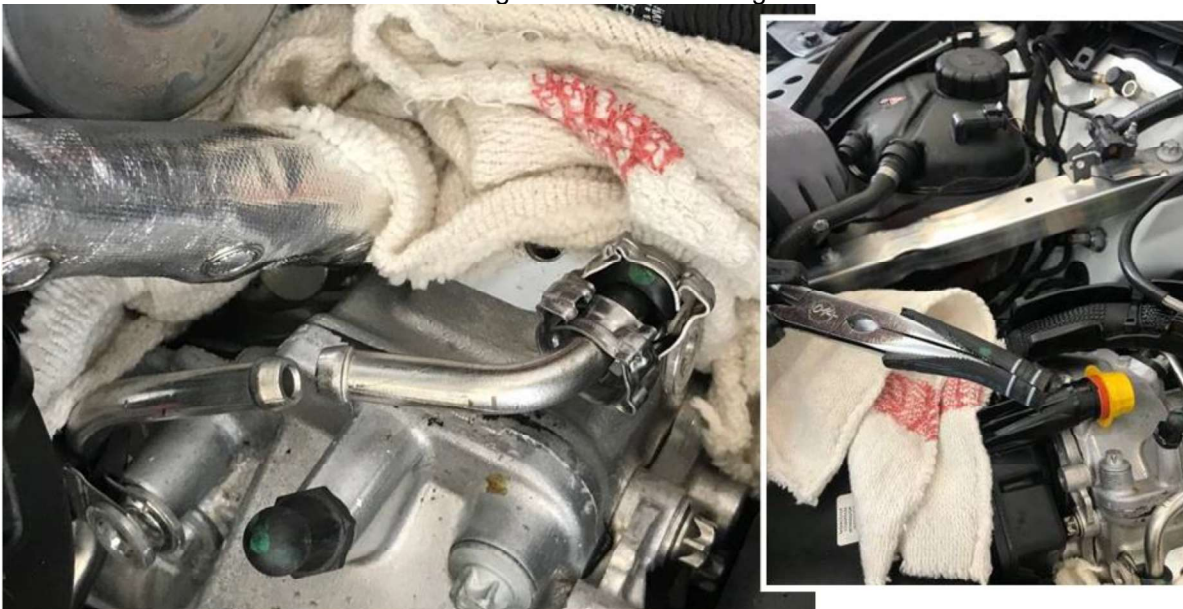
Figure 3

5. Open CLIC clamps on the braided hose and take off (**figure 3, left**). Carefully cut through the braided hose along its length and remove from the metal line (**figure 3, right**).

i This makes it easier to remove the braided hose from the metal line.

i Cover work environment with a rag so that the remaining fuel is collected.

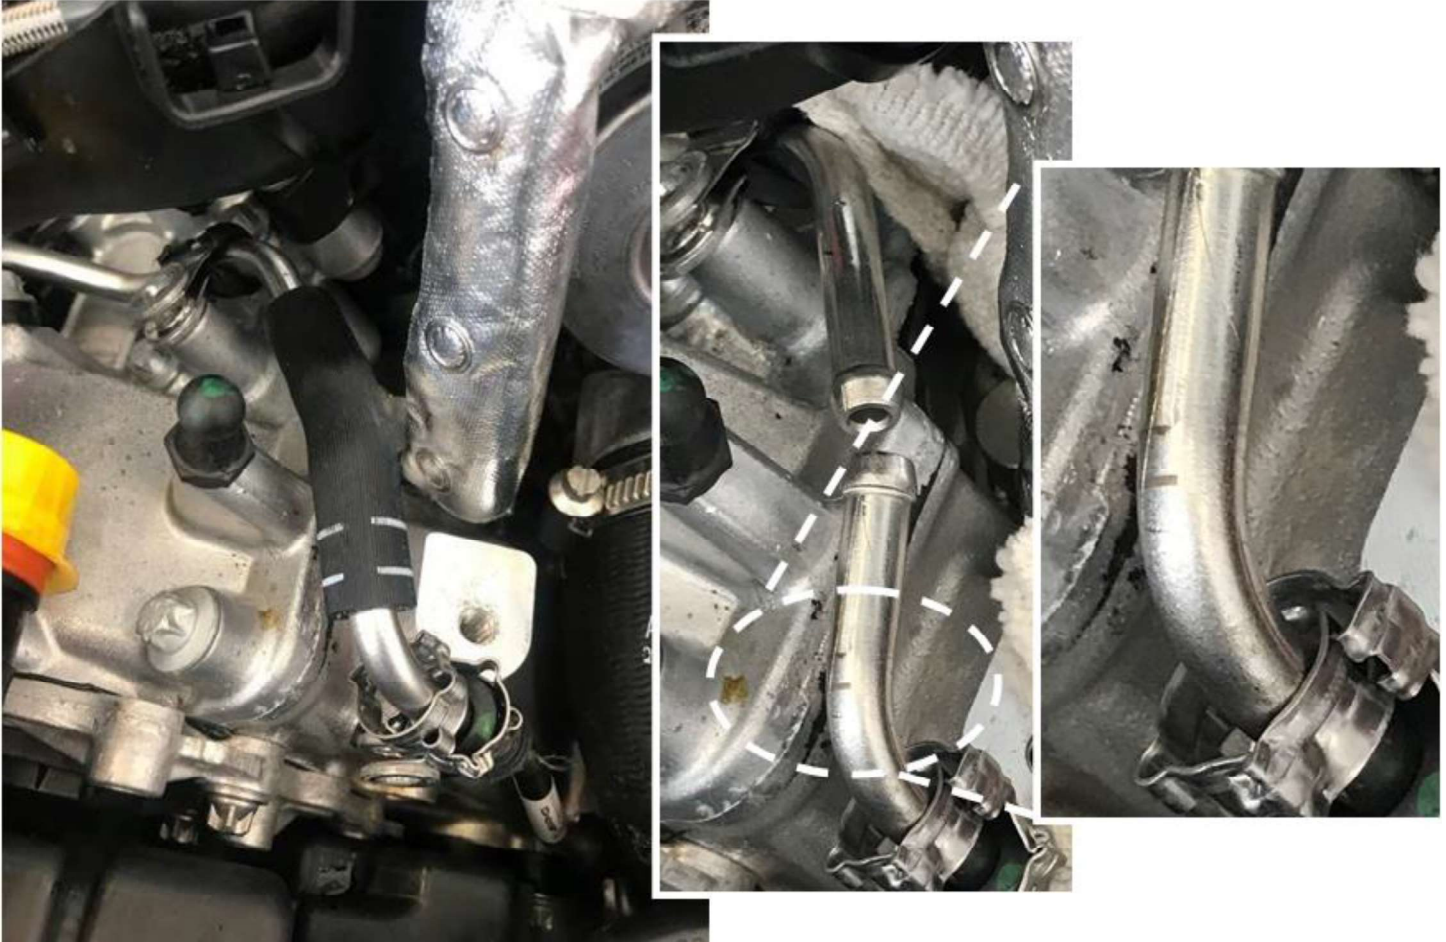
Figure 4

6. Slide on new braided hose, position, and fasten with new CLIC clamps.

i Slide CLIC clamps onto line before the fabric hose.

i Position braided hose on metal line based on markings (**figure 4, middle and right**).

i Metal lines must not be bent during assembly!

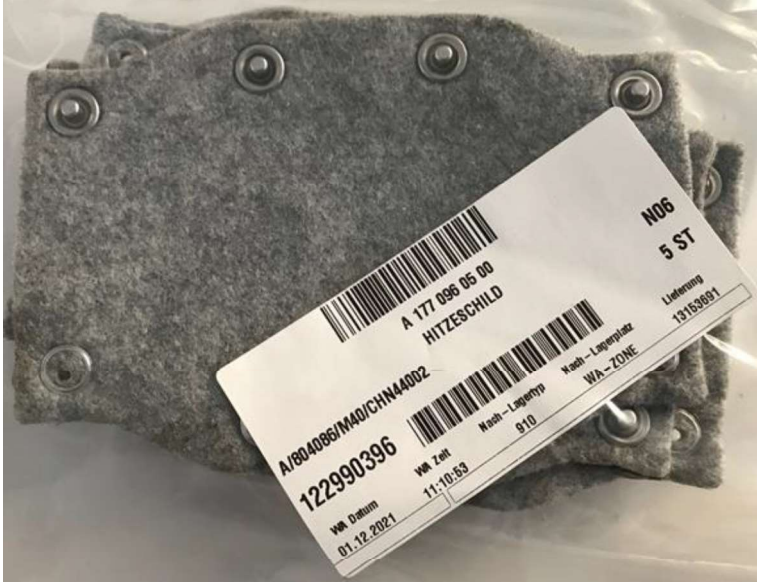
Figure 5

7. Install heat shield over the new braided hose.

i Close snap fasteners.
