MODEL 222.0/1/9

Shown on vehicle with CODE 582 (Rear air conditioning)

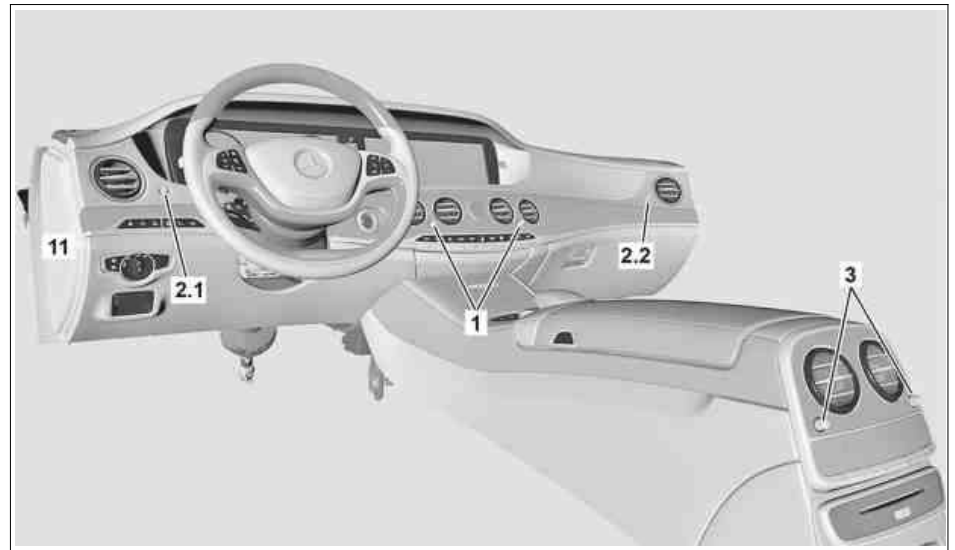
P83.10-2851-05

- 1 Center potentiometer
- 2.1 Left potentiometer
- 2.2 Right potentiometer
- 3 Rear potentiometer
- 11 Side cover

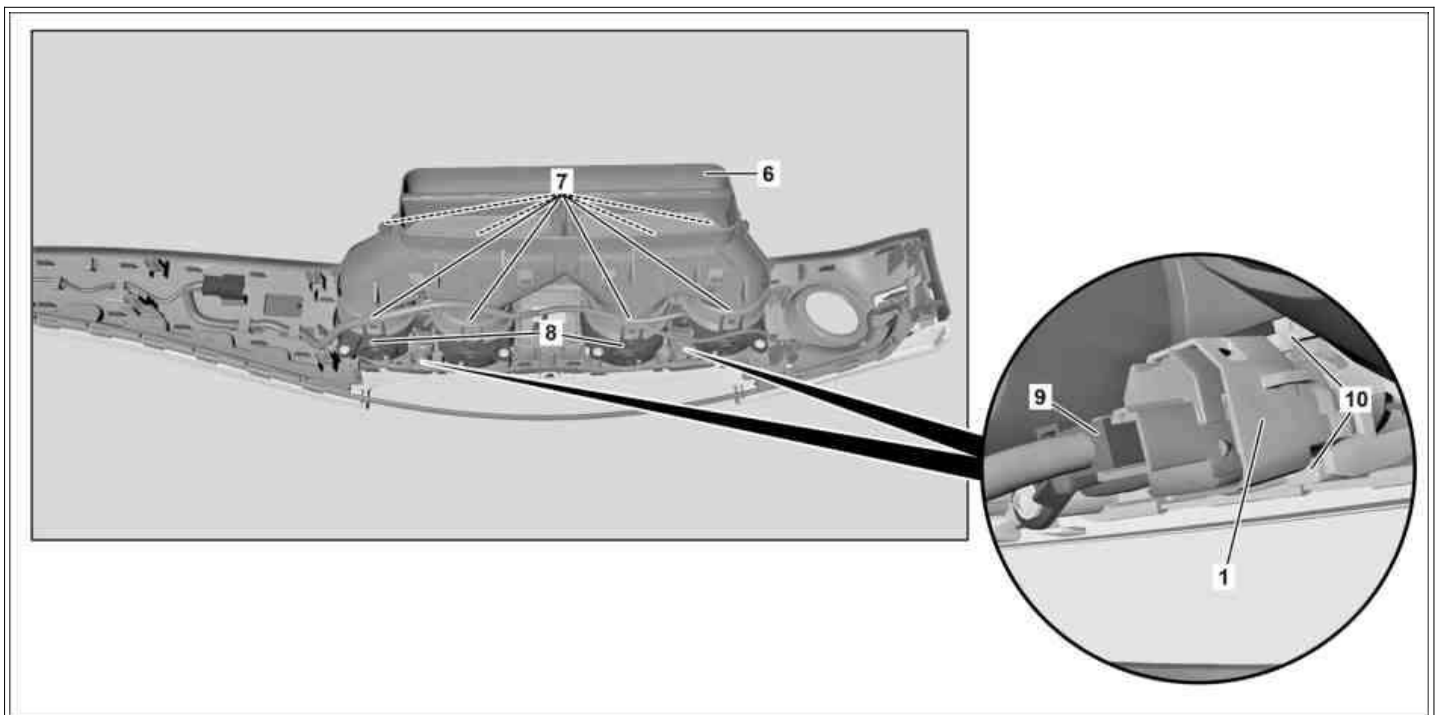
P83.10-2853-09

Center potentiometer

| 1 Center potentiometer | 8 Center air vent |
| 6 Air duct segment | 9 Electrical connector |
| 7 Retaining tabs | 10 Catch lug |

Remove/install		
1	Switch off ignition and remove transmitter key		
	Remove center potentiometer (1)		
2	Remove trim piece from instrument panel		AR68.10-P-1180LF
3	Remove air conditioning pushbutton control unit		AR83.25-P-1124LF
4	Disconnect electrical connector (9) at center potentiometer (1)		
5	Loosen retaining tabs (7) of air duct segment (6)		
6	Remove air duct segment (6)		
7	Lift catch tabs (10)		
8	Remove center potentiometer (1) toward rear		
	Remove left potentiometer (2.1)		
9	Remove side cover (11)		
10	Remove fuse and relay module (12)		
11	Disconnect electrical connector (9) at left potentiometer (2.1)		
12	Lift catch tabs (10)		
13	Press left potentiometer (2.1) out in direction of arrow		
	Remove right potentiometer (2.2)		
14	Remove glove compartment		AR68.10-P-1400LF

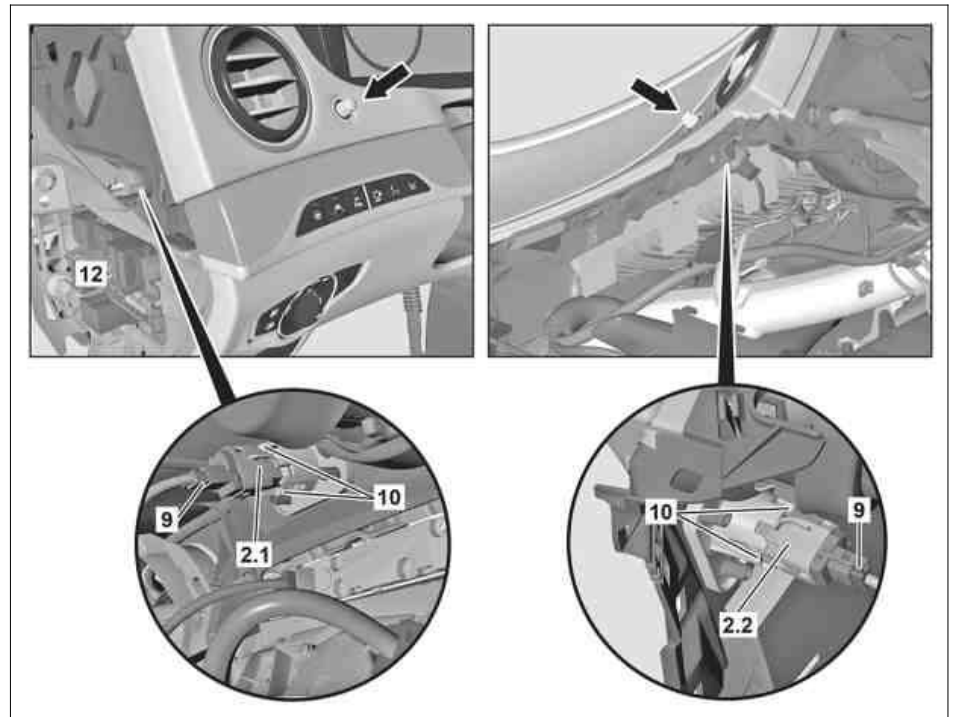
P83.10-2854-06

Left/right potentiometer

- 2.1 Left potentiometer
- 2.2 Right potentiometer
- 9 Electrical connector
- 10 Catch lug
- 12 Fuse and relay module

15	Disconnect electrical connector (9) at right potentiometer (2.2)		
16	Lift catch tabs (10)		
17	Press right potentiometer (2.2) out in direction of arrow		
	Remove rear potentiometer (3)		
18	Remove cover on center console		AR68.20-P-2350LF
19	Lift catch tabs (10)		
20	Press rear potentiometer (3) out in direction of arrow		
21	Install in the reverse order

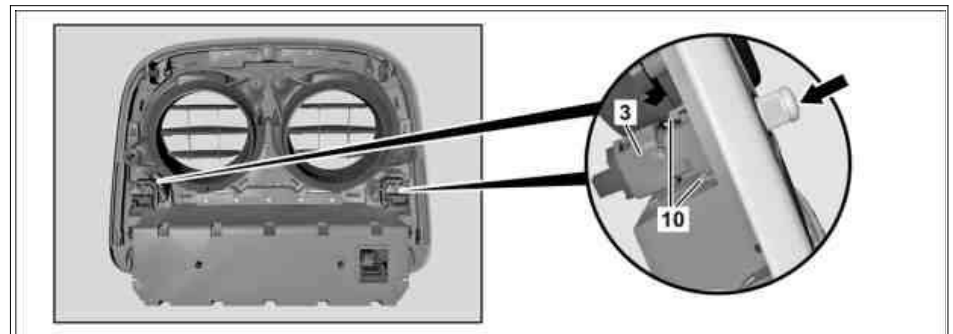
P83.10-2852-04

Rear potentiometer, shown on vehicle with CODE 582 (Rear air conditioning)

- 3 Rear potentiometer
- 10 Catch lug
