Model 223

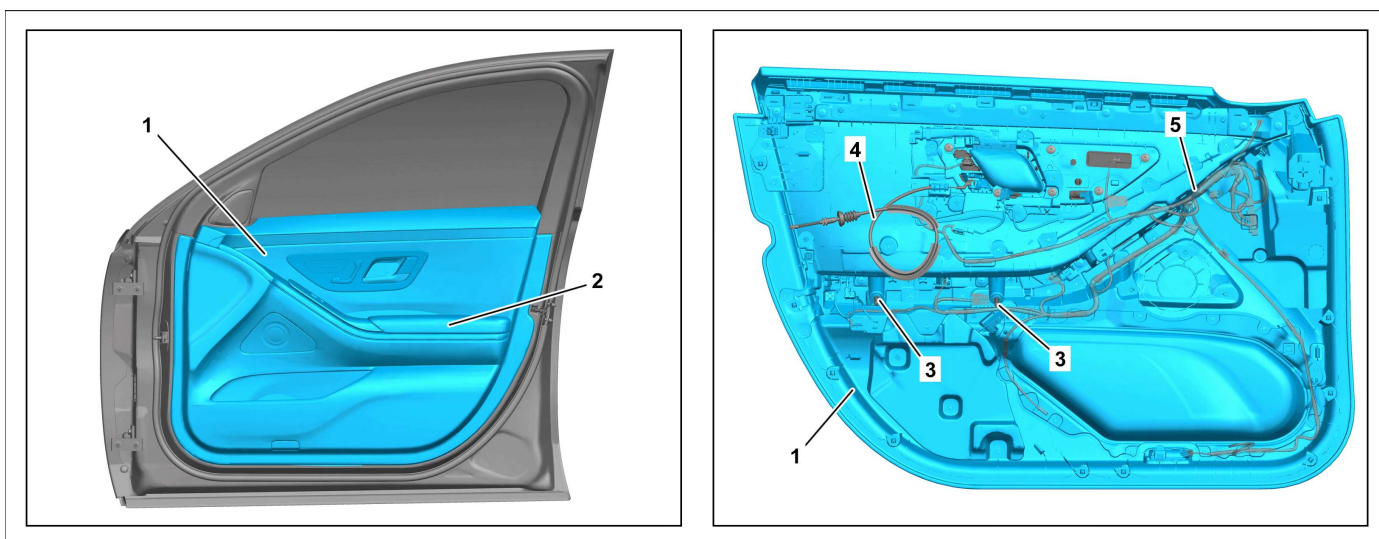
P72.10-A053-78

Shown on model 223 except code Z07 (B7 Armoring for special protection version)

- 1 Door trim
- 2 Armrest
- 3 Screw

- 4 Wire
- 5 Electrical wiring harness

Long wedge	*115589035900
3	Remove armrest (2).	Model 223 except code Z07 (B7 armoring on special protection version)	AR72.10-P-1035S
4	Remove screws (3).		
5	Starting from the bottom, unclip door trim (1) and remove from sealing rail.

Long wedge	*115589035900
6	Lift door trim (1) until electrical connectors of electrical wiring harness (5) and wire (4) can be accessed.

Start at top front with the lifting.	
7	Detach wire (4) of inside door opener.		
8	Disconnect electrical connectors at front door control unit and at mid-range speaker.

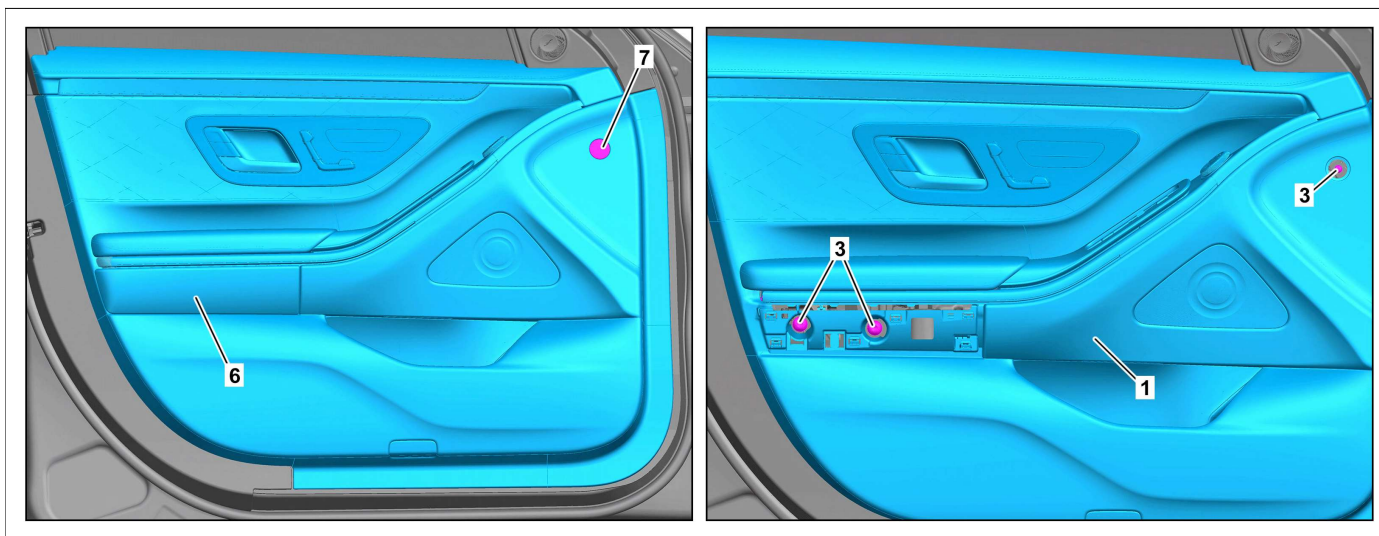
P72.10-A160-78

Shown on model 223 with code Z07 (B7 Armoring for special protection version)

- 1 Door trim
- 3 Bolts

- 6 Cover
- 7 Cover

2	Remove covers (6, 7).	Model 223 with code Z07 (B7 armoring on special protection version)
