MODEL 230.467 /474 /475 /476 /479

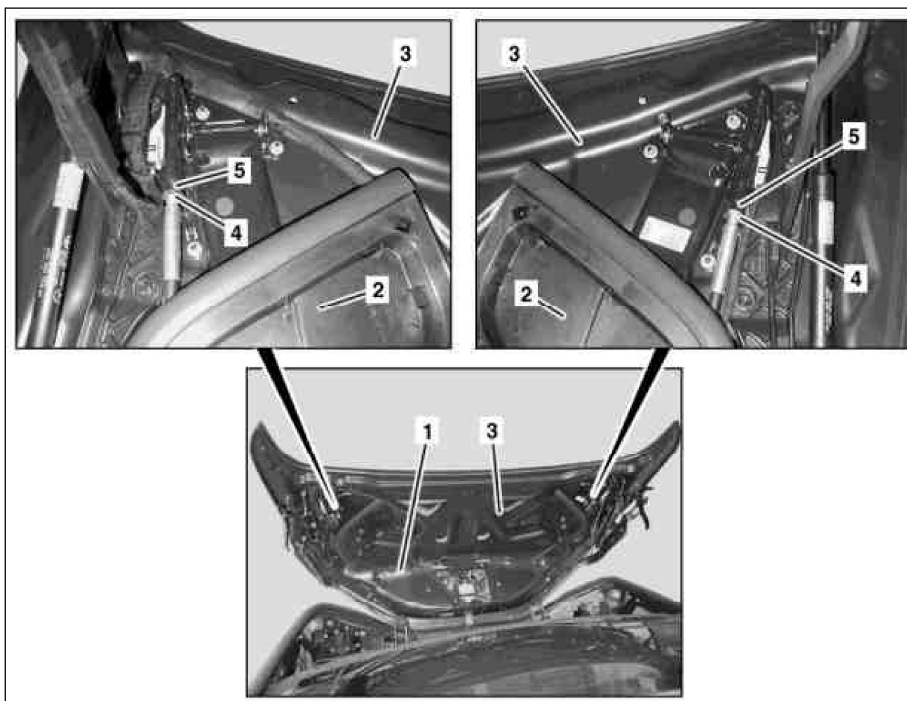
P77.30-2113-06

- 1 Side flap drive
- 2 Side flaps
- 3 Trunk lid
- 4 Locknut
- 5 Adjusting nut

☐	Check		
⚠ Danger!	Risk of injury. Moving parts can pinch, crush or, in extreme cases, even sever extremities.	No parts of the body or limbs should be within the operating range of the mechanism when moving components.	AS00.00-Z-0009-01A
i	Correct adjustment of the side flap drive (1) allows uniform motion of both side flaps (2). Moreover, it prevents the side flaps (2) from making noises when the Vario roof is open. Vario roof must be closed		
1	Actuate soft top switch until tailgate is opened	i The side flaps (2) must be completely folded in	
2	Check adjustment of side flaps (2) when folded in	i Both side flaps (2) should make uniform contact with the trunk lid (3) under tension	
	Adjust		
3	Loosen counternut (4) and turn adjusting nut (5)	i Turn adjusting nut (5) until both side flaps (2) make uniform contact with the trunk lid (3) under tension	
4	Tighten locknut (4)		
5	Actuate soft top switch until side flaps (2) are completely folded out

6	Check adjustment of side flaps (2) when folded out	i Both side flaps (2) should make uniform contact with trunk lid (3)	
7	Loosen counternut (4) and turn adjusting nut (5)	i Turn adjusting nut (5) until both side flaps (2) make uniform contact with the trunk lid (3) under tension	
8	Tighten locknut (4)		
9	Fold side flaps (2) in and out twice using the soft top switch		
10	Check adjustment of side flaps (2) when folded in or out; if necessary, repeat adjustment	i If the side flaps (2) do not make contact in both positions with the trunk lid (3) under tension, adjust the side flap drive (1) so that the side flaps (2) make contact with the trunk lid (3) on the inside with tension in the folded-in state. This prevents noises when the Vario roof is open whereby the side flaps (2) do not make noises when the Vario roof is closed.
