MODEL 231

P82.10-7190-08

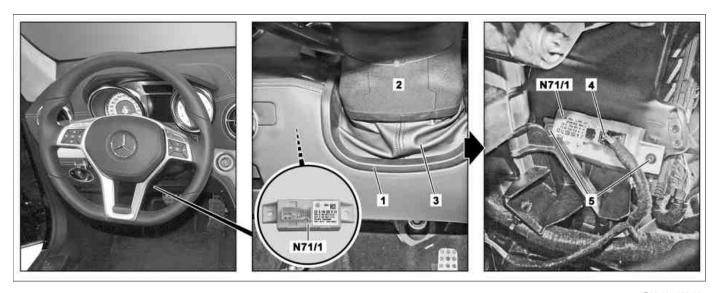
- Frame
- 2 3 Steering column module
- Cover

- Electrical connector
- Screw
- N71/1 Headlamp control unit

(9)	Information on preventing damage to electronic components due to electrostatic discharge		AH54.00-P-0001-01A
器 無	Remove/install		
1	Connect STAR DIAGNOSIS and perform initial startup of headlamp control unit (N71/1)	When replacing headlamp control unit (N71/1).	
F A D	Connect STAR DIAGNOSIS and read out fault memory		AD00.00-P-2000-04A
2	Move driver seat to rearmost position		
3	Switch off ignition and remove transmitter key (A8/1) or KEYLESS-GO start/stop button (S2/3) from electronic ignition lock control unit (N73)	i KEYLESS-GO start/stop button (S2/3) only with code (889) KEYLESS-GO.	
4	Remove cover below dashboard		AR68.10-P-1500RK
5	Release cover (3) from steering column tube module (2)	To do so, press the cover's (3) frame (1) off the steering column tube module (2). For a better view of the headlamp control unit (N71/1). Long wedge	*115589035900
6	Disconnect electrical connector (4)	Long weage	11000000000

7	Remove bolts (5)		
8	Remove headlamp control unit (N71/1)		
9	Install in the reverse order
