MODEL 211.0/ 2/ 6

Remove/Install		
1	Remove instrument cluster		AR54.30-P-6015T
2	Remove paneling from left A-pillar		AR68.30-P-4050T
3	Unclip left cover (3) with mounting wedge

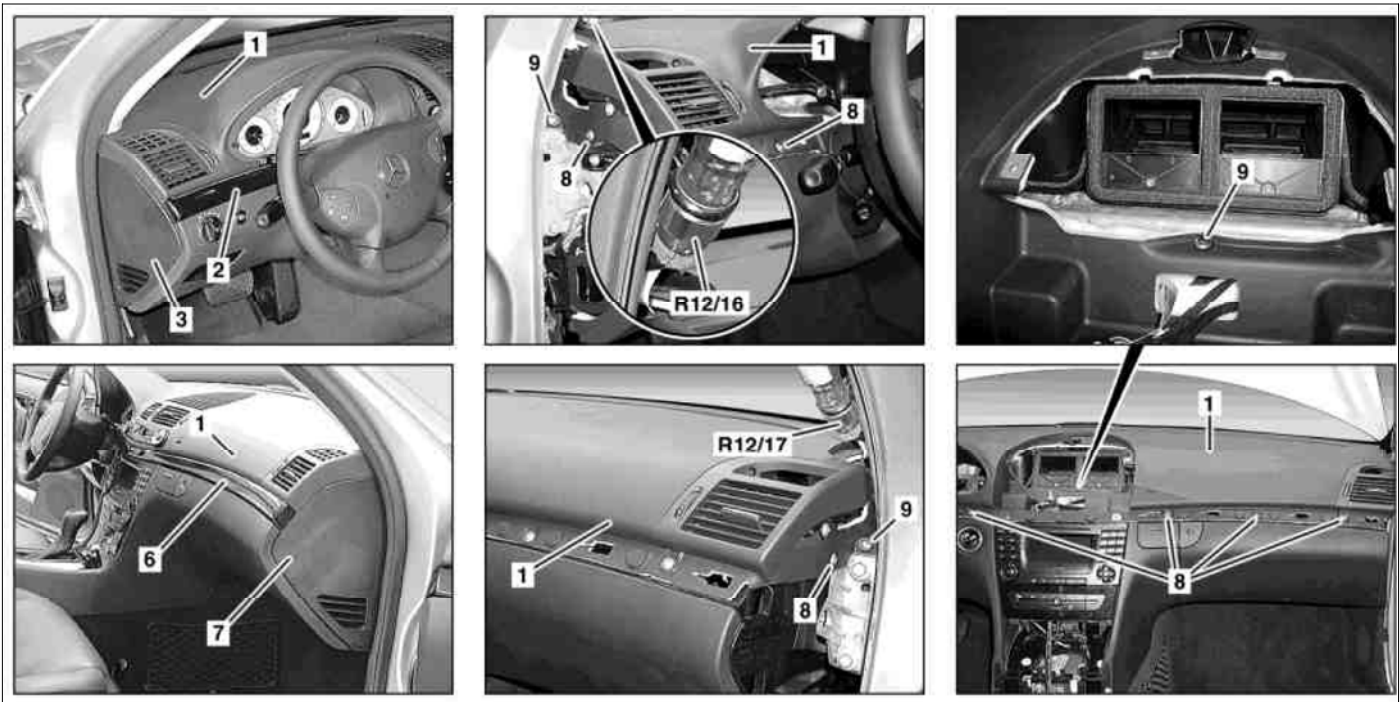
P68.10-2988-09

- 1 Instrument panel upper section
- 2 Left trim strip
- 3 Left cover
- 6 Right trim strip

- 7 Right cover
- 8 Bolts
- 9 Bolt

- R12/16 Left front window bag squib (on model 211.0 and 211.2)
- R12/17 Right front window bag squib (on model 211.0 and 211.2)

*110589035900
4	Remove left trim strip (2) from instrument panel.		AR68.10-P-1180T
5	Remove paneling on right A-pillar		AR68.30-P-4050T
6	Unclip right cover (7) with mounting wedge

*110589035900
7	Remove right trim strip from instrument panel		AR68.10-P-1180T
8	Remove front pushbutton control module		AR83.40-P-6350T

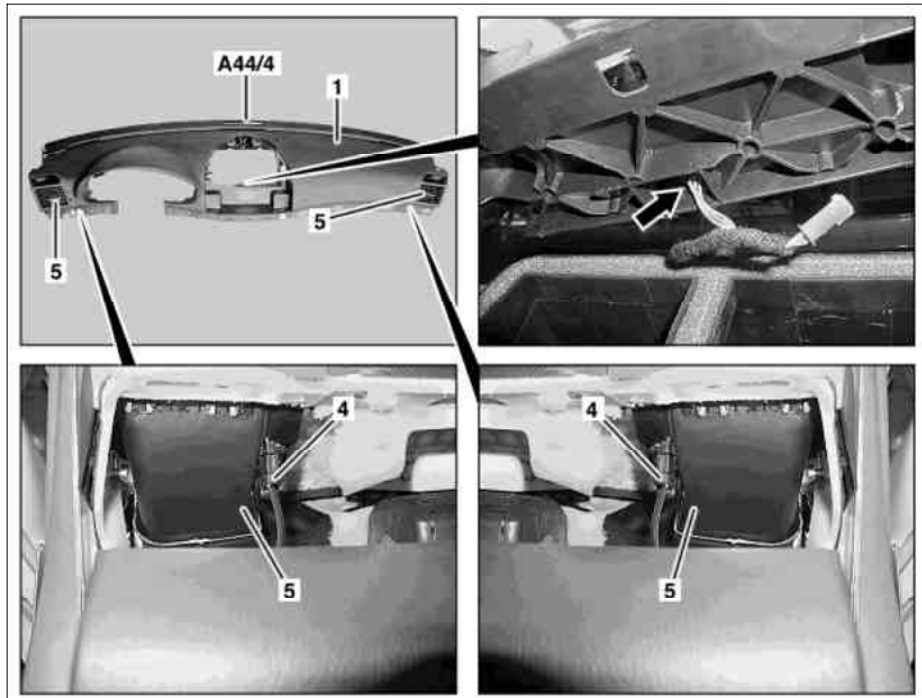
P68.10-2726-06

- 1 Instrument panel upper section
- 4 Electrical connector
- 5 Air nozzle
- A44/4 PTS warning display, center of instrument panel

9	Remove bolts (8)		
<b>⚠ Danger!</b>	<b>Risk of fire and explosion caused by machining/treating magnesium components</b> Remove bolts (9)	Keep away from ignition sources and open flames. <b>i</b> The cross member below the instrument panel into which the bolts (9) are screwed, consists of a magnesium alloy.	AS60.00-Z-0006-01R
10	<b>ⓘ</b> Notes on processing magnesium components		AH60.00-P-0023-01R
11	Lift instrument panel upper section (1) and disconnect electrical connectors (4) from air nozzles (5)		
12	With the help of a second person, detach instrument panel upper section (1) from the right side to the rear of the cross member under the instrument panel	<b>ⓘ</b> On model 211.0 and 211.2 carefully move instrument panel bottom section (1) along right A-pillar. Otherwise the electrical connector on the right front windowbag squib (R12/17) can break. <b>i</b> On vehicles with code (220a) Parktronic system (PTS), remove only until electrical connector (arrow) on center instrument panel PTS warning display (A44/4) is accessible.

13.1	Disconnect electrical connector (arrow) from the center instrument panel PTS warning indicator (A44/4)	On vehicles with code (220a) Parktronic system (PTS) <b>i</b> While disconnecting the electrical connector, the instrument panel upper section (1) must be held by a second person.	
14	With the help of a second person, detach instrument panel upper section (1) from the left side to the rear from the cross member under the instrument panel and remove out of the vehicle	<b>ⓘ</b> On model 211.0 and 211.2 carefully move instrument panel bottom section (1) along left A-pillar. Otherwise the electrical connector on the left front window bag squib (R12/16) can break.	
15	Install in the reverse order
