P82.60-5390-09

Shown on model 221

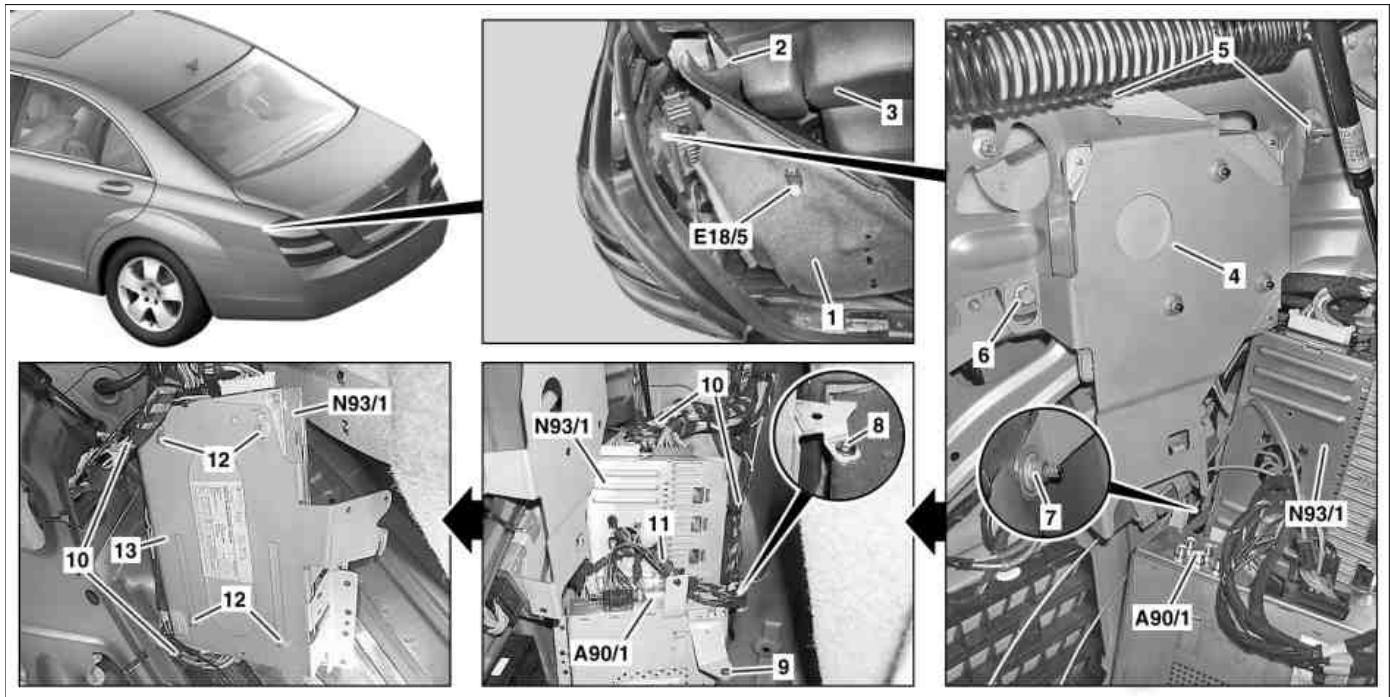
| <p>1 Side trunk paneling

2 Hinge lever passage frame
3 Trunk floor paneling
4 Bracket
(with code (218) Backup camera or code (390 to 396) Linguatronic or code (529) HIGH Class Japan or code (813) Voice control system (VCS [SBS]))</p> | <p>5 Nuts
(with code (218) Backup camera or code (390 to 396) Linguatronic or code (529) HIGH Class Japan or code (813) Voice control system (VCS [SBS]))
6 Screw
(with code (218) Backup camera or code (390 to 396) Linguatronic or code (529) HIGH Class Japan or code (813) Voice control system (VCS [SBS]))
7 Nut</p> | <p>8 Screw
9 Bolt (for code (863) Digital/analog TV tuner)
10 Wiring harness
11 Wiring harness (for code (863) Digital/analog TV tuner)
12 Nuts
13 Bracket

A90/1 TV combination tuner (analog/digital) (for code (863) Digital/analog TV tuner)
E18/5 Left luggage compartment lamp
N93/1 Audio tuner control unit</p> |

Remove/install		
	Information on preventing damage to electronic components due to electrostatic discharge		AH54.00-P-0001-01A
	Temporarily store basic data of audio tuner control unit (N93/1) in STAR DIAGNOSIS Connect STAR DIAGNOSIS and read out fault memory	When replacing audio tuner control unit (N93/1). i Installation: Copy temporarily stored basic data to new audio tuner control unit (N93/1).	AD00.00-P-2000-04A
	Switch off ignition and withdraw transmitter key or Keyless Go start/stop button from the EIS [EZS] control unit	i Keyless Go start/stop button only for vehicles with code (889) Keyless Go.	
	Remove spare tire well paneling	On model 216	AR68.30-P-4600SX
	Release trim at side in luggage compartment (1) and swivel to one side until the audio tuner control unit (N93/1) is accessible		AR68.30-P-4600SX
	Loosen nuts (5) and bolt (6), detach bracket (4) and place to one side with lines connected	For vehicles with code (218) Backup camera or with code (390 up to 396) Linguatronic or with code (529) HIGH Class Japan or with code (813) Voice control system (VCS [SBS])

Remove nut (7)		
	Unscrew bolt (8)		
	Unscrew bolt (9)	For vehicles with code (863) Digital/analog TV tuner

9 ⓘ	Raise bracket (13), place to one side and detach electrical connectors on audio tuner control unit (N93/1) Notes on avoiding damage to fiber optic cables during repair work	ⓘ Do not twist wiring harness (11) (for code (863) Digital/analog TV tuner) and wiring harness (10) too far as otherwise the fiber optic cable may be damaged.	AH82.60-P-0001-05AK
10	Undo nuts (12) and remove audio tuner control unit (N93/1) from bracket (13)		
11	Install in the reverse order
