Shift Module Removal

Instructions for replacing the Lever Position Detection Module located on the Electronic Shift Module.

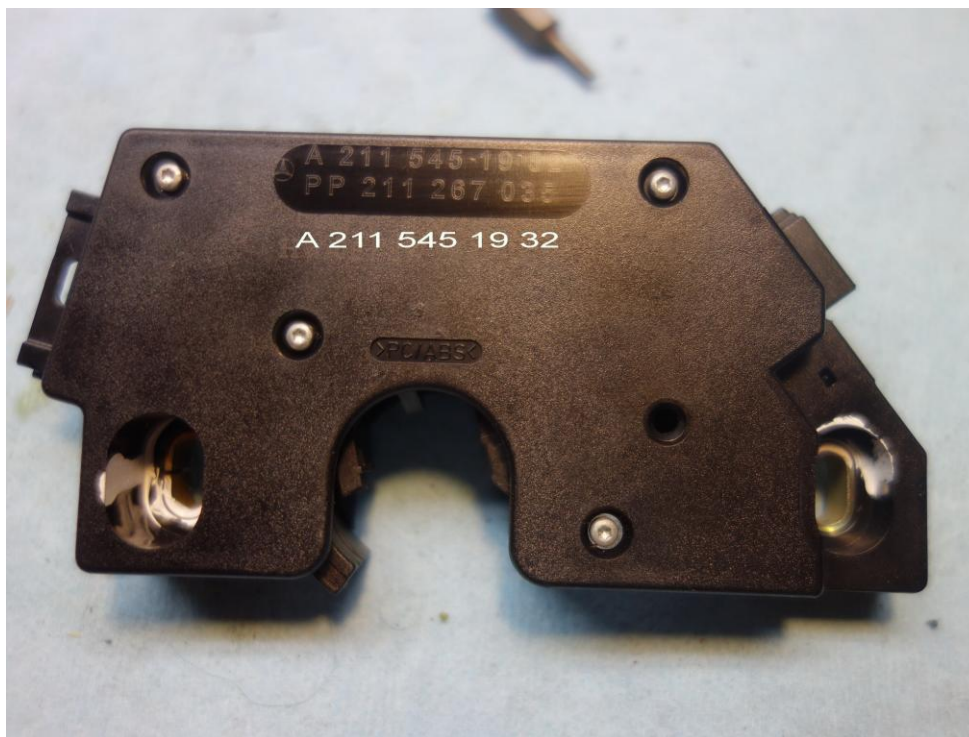
Research showed the following module was most likely at fault (often the opto-sensors):

The module can be replaced with a repaired module or your module can be sent to a repair shop with the attendant shipping delay. I purchased a repaired module off of Ebay for \$135.
