Service Campaign Bulletin

Campaign No. 2019080019, November 2019

SUBJECT: **Various Models**
Model Years 2012-2017

Replace Steering Gear Bolts

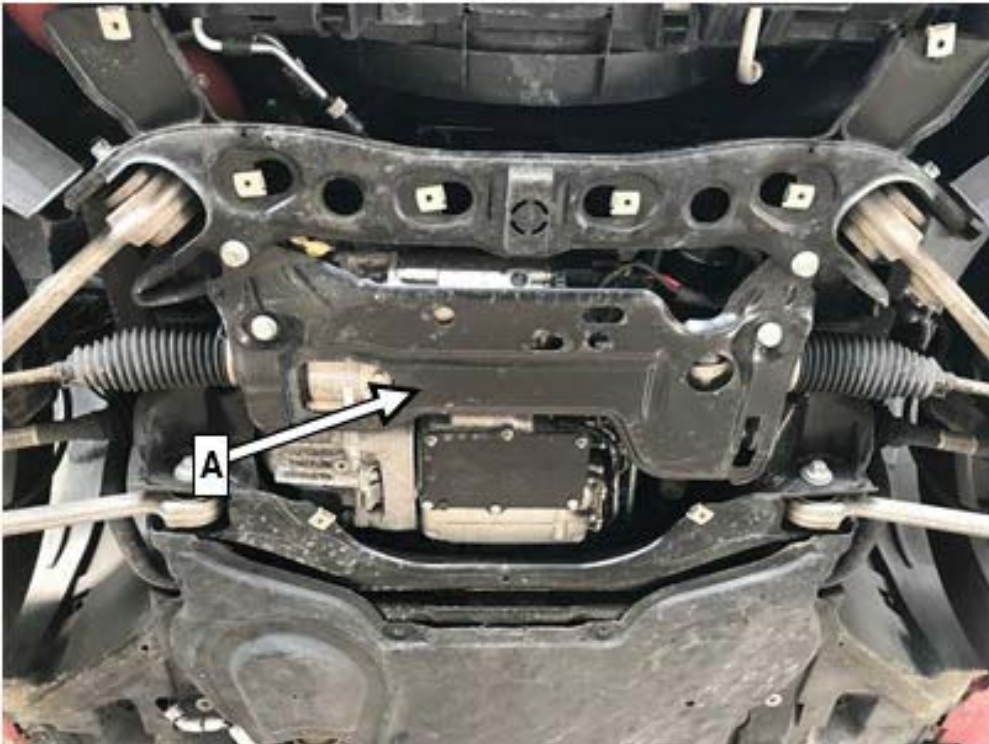
Figure 1

1. Remove center section of lower engine compartment lining.
2. Remove mounting plate (A, Figure 1) for steering gear.
 - i** For basic data, see **AR46.20P-0600EL**.
 - i** For basic data, see **AR46.20-P-0600LF**.

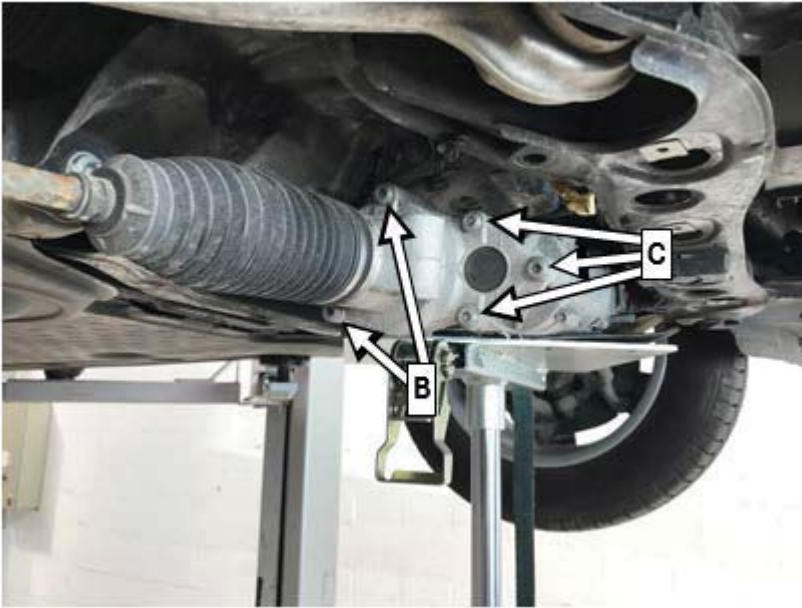
Figure 2

4. Remove screws (B and C, Figure 2), making **absolutely sure** to do so **individually and one after the other**, replace with new steel screws and tighten with the specified torque incl. tightening angle.

- i** The procedure must be completed so that the power-pack does not twist away from its set position thus resulting in consequential damage.
 - Nm** Power-pack screw on steering gear: **5 Nm and 90°** tightening angle.

- i** If a **screw** should **break off** or have already broken off, **replace the electric power steering rack.**
 - i** For basic data, **see AR46.20-P-0600EL and AR46.20-P-0600EF.**

1. Remove center section of lower engine compartment lining.
2. Remove screws (B and C, Figure 2), making **absolutely sure** to do so **individually and one after the other**, replace with new steel screws and tighten with the specified torque incl. tightening angle.

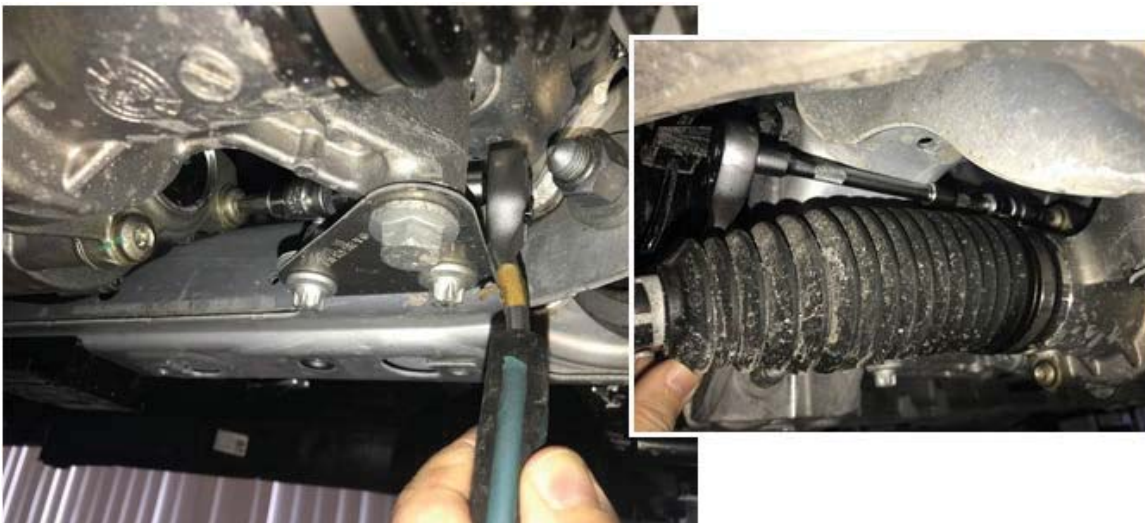
Figure 4

- i** The procedure must be complied with so that the power-pack does not twist away from its set position thus resulting in consequential damage.
 - i** For models 205, 213, 238, and 253, the steering **does not have** to be released from the front axle carrier.

- Nm** Power-pack screw on steering gear: **5 Nm and 90°** tightening angle.
 - i** If a **screw** should **break off** or have already broken off, **replace the electric power steering rack**.

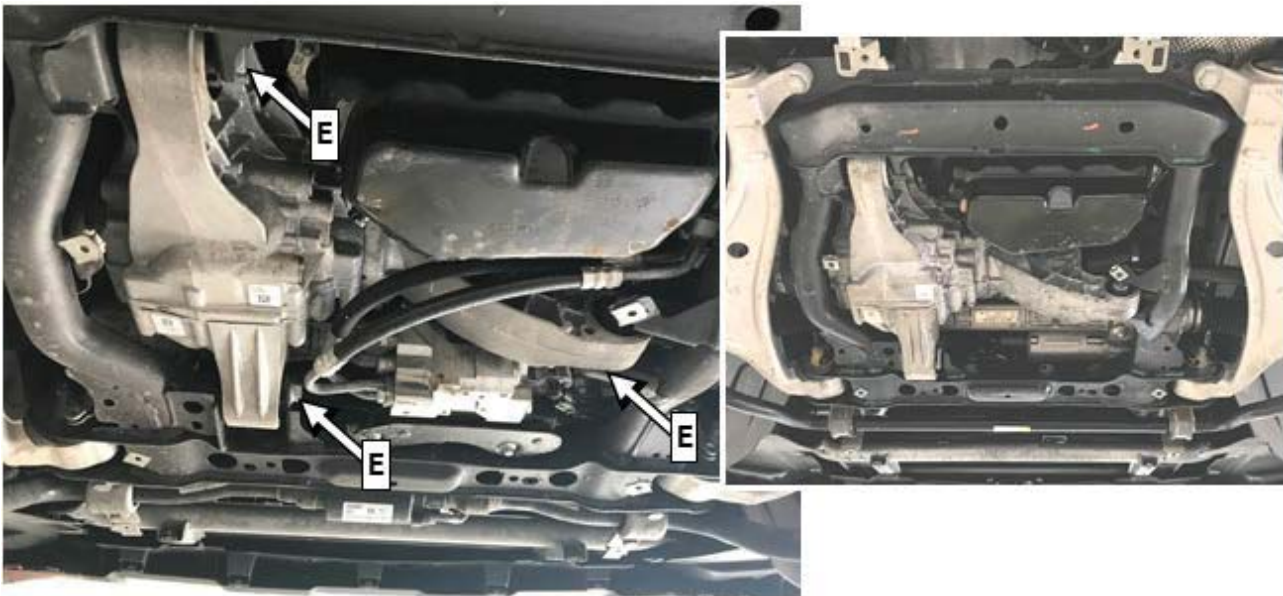
Figure 5

1. Remove center section of lower engine compartment lining.
2. Remove screws (E, Figure 5) connecting the front axle differential to the front axle carrier.
 - i** Front axle differential remains lying in front axle carrier. It is only slightly lowered.
 - i** **No further** threaded connections are released at front axle differential.
 - i** For basic data, see **AR33.30-P-0525GQ**

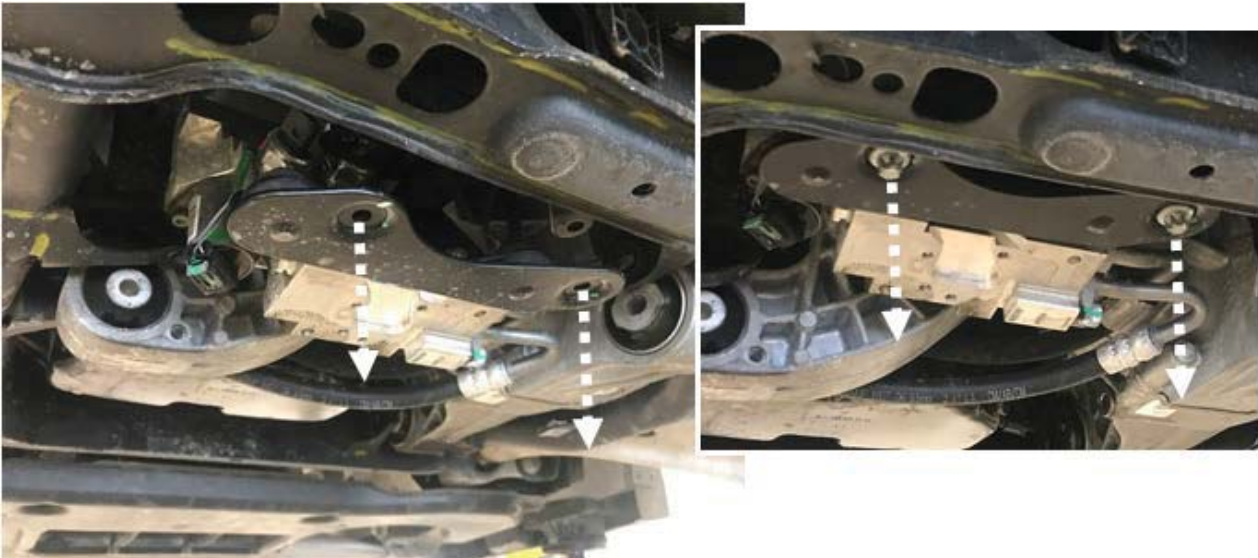
Figure 7

4. For vehicles **with code 468 (Active Curve System)**, unscrew the hydraulics block (**Figure 7**) and slightly press downwards with lines connected.

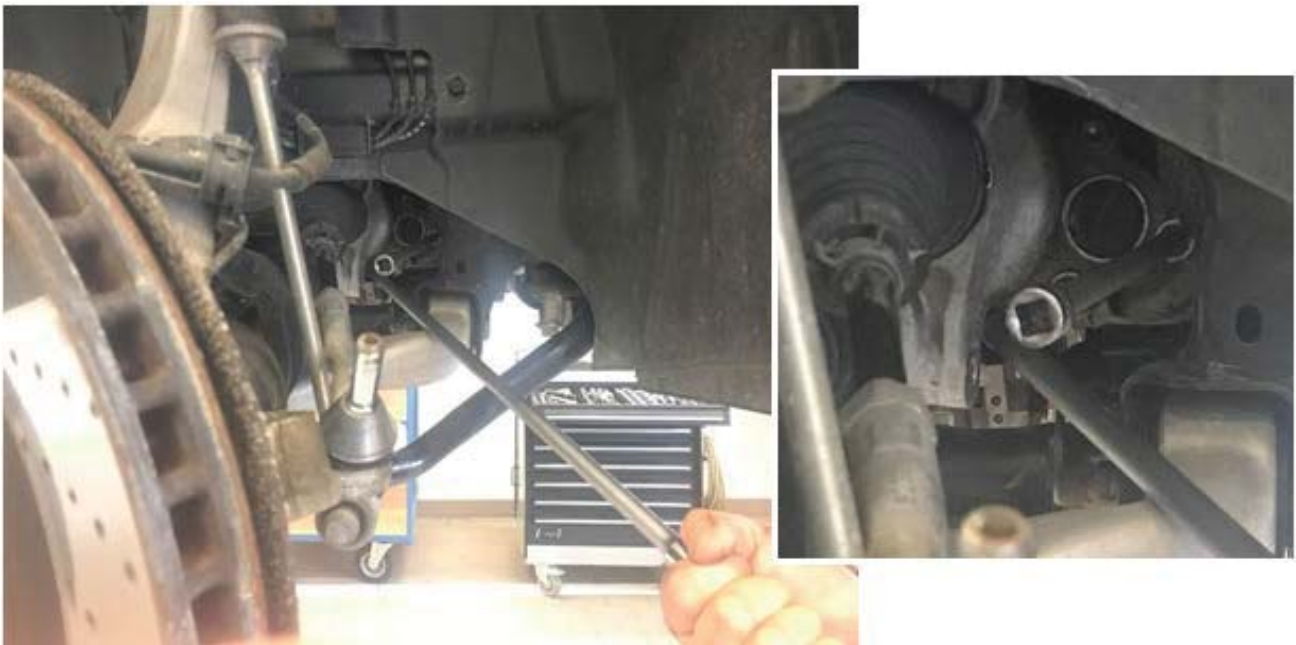
Figure 9

i Keep the steering pressed towards the rear with the aid of a helper as shown (**Figure 9**).
