- Model 166**
up to model year 2016
- Model 204.9**
with code 220 (PARKTRONIC system (PTS))
with code 430 (Offroad package)
with code 873 (Left and right driver's seat heating)
- Model 207, 212, 218**

Shown on model 204.9 up to model year 2013

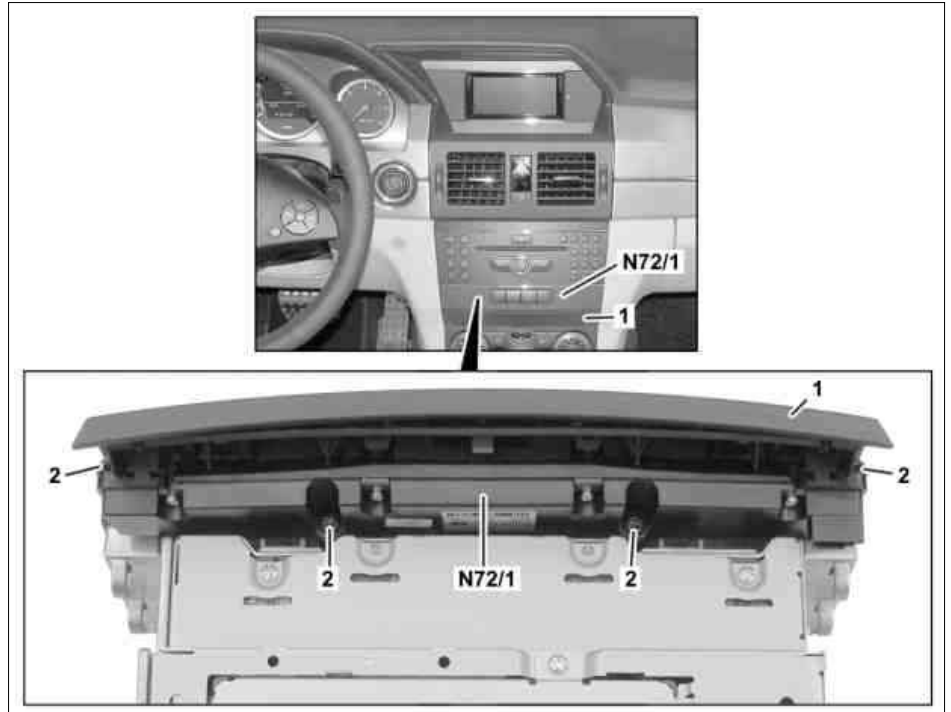
P54.21-3011-06

- 1 Panel
- 2 Screw
- N72/1 Upper control panel control unit

Information on preventing damage to electronic components due to electrostatic discharge		AH54.00-P-0001-01A
☒ ☒	Remove/install		
1	Remove radio	Model 166 up to model year 2016 Model 204.9 as of model year 2013 with code 220 (PARKTRONIC system (PTS)) with code 430 (Offroad package) with code 510 (Audio 20 CD with 6-disc CD changer) with code 512 (COMAND APS with DVD changer) with code 523 (Audio 20 CD) with code 527 (COMAND APS with single DVD drive (with navigation)) with code 873 (Left and right driver's seat heating)	AR82.60-P-7502GQ AR82.60-P-7502CY
