MODEL 207, 212, 218

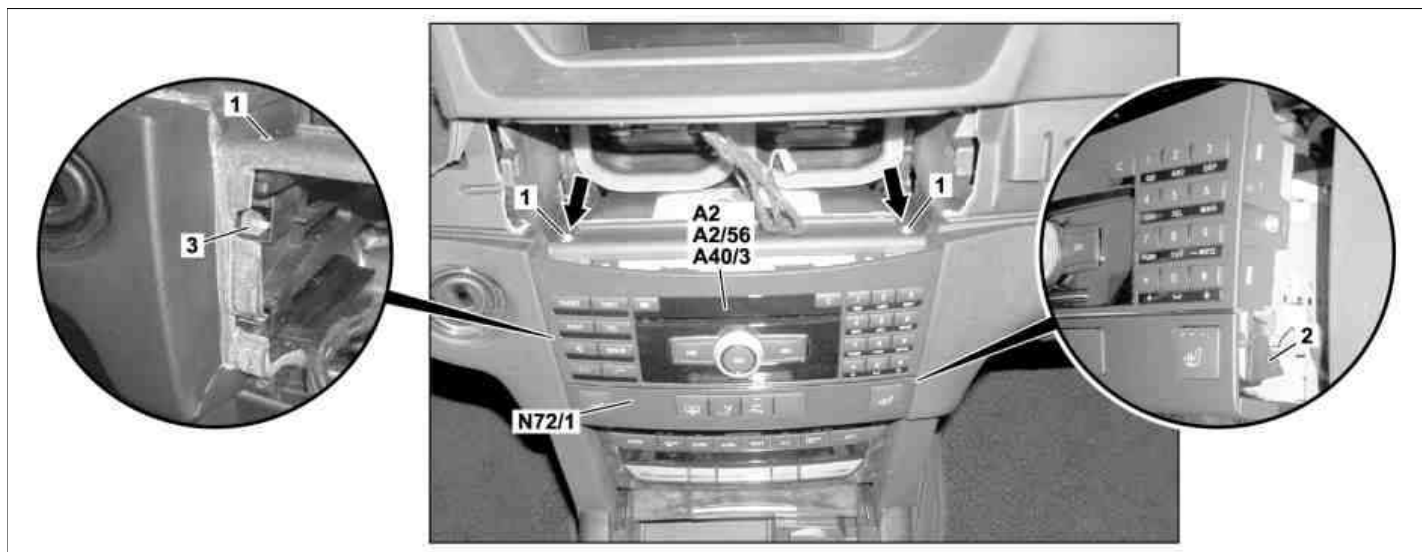
P82.60-7926-08

Shown on model 212 with open lock

1	Screw	A2	Radio (with CODE 505 (Radio 20 NTG5 without navigation capability) or with CODE 510 (Audio 20 with CD changer) or with CODE 522 (Audio 20 radio) or with CODE 523 (MB Audio 20 radio))	N72/1	Upper control panel control unit
2	Electrical connector	A2/56	Radio with auto pilot system (with CODE 511 (Audio 50 APS with DVD changer) or with CODE 525 (MB Audio 50 APS radio))		
3	Lock	A40/3	COMAND controller unit (with CODE 512 (COMAND APS with DVD changer) or with CODE 526 (COMAND (without navigation)) or with CODE 527 (COMAND APS with single DVD drive (with navigation)) or with CODE 528 (COMAND with DVD changer USA (without navigation)) or with CODE 531 (COMAND APS))

2.1	Switch off ignition and remove transmitter key from electronic ignition lock control unit	MODEL 207, 212, 218 without CODE 889 (KEYLESS-GO)	
2.2	Switch off ignition and remove transmitter key or KEYLESS-GO start/stop button from electronic ignition lock control unit	MODEL 207, 212, 218 with CODE 889 (KEYLESS-GO)	
3	Remove Audio/COMAND display	MODEL 218 as of model year 2015	AR82.60-P-7722ELA
4	Remove trim piece from right instrument panel	MODEL 212, 218 MODEL 212 MODEL 218	AR68.10-P-1180EW AR68.10-P-1180EL
5	Remove center air vents	MODEL 207	AR83.10-P-4503EC
6	Unclip cover (4) from instrument panel (arrows B) and remove	MODEL 218 as of model year 2015	
7	Completely remove screws/bolts (1), position screws/bolts (1) again and press screws/bolts (1) in direction of arrow so that lock (3) is opened

The lock (3) must be completely opened. Otherwise, the radio (A2) or the radio with auto pilot system (A2/56) or the COMAND controller unit (A40/3) can be damaged.

8	Cover center console with a dry cloth and pull radio (A2) or radio with auto pilot system (A2/56) or COMAND controller unit (A40/3) far enough out of the instrument panel for the electrical connector (2) of the upper control panel control unit (N72/1) to be accessed		
9	Disconnect electrical connector (2) of upper control panel control unit (N72/1)		
10	Pull radio (A2) or radio with auto pilot system (A2/56) or COMAND controller unit (A40/3) far enough out of instrument panel until electrical connectors or optical fiber connector are accessible on the back of the unit		
11	Disconnect electrical connectors and optical fiber connector on back of radio (A2) or radio with auto pilot system (A2/56) or COMAND controller unit (A40/3), unhook retaining clip and remove radio (A2) or radio with auto pilot system (A2/56) or COMAND controller unit (A40/3)		
12	Remove upper control panel control unit (N72/1)	When replacing radio (A2) or radio with auto pilot system (A2/56) or COMAND controller unit (A40/3).	AR54.21-P-1262CY

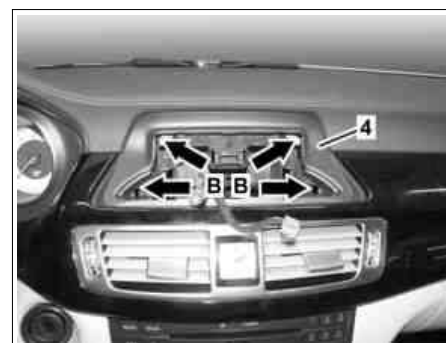
P82.60-9473-01

MODEL 218 as of model year 2015

4 Cover
