TRANSMISSION 722.9 in MODEL 172, 212, 218

P27.30-2012-08

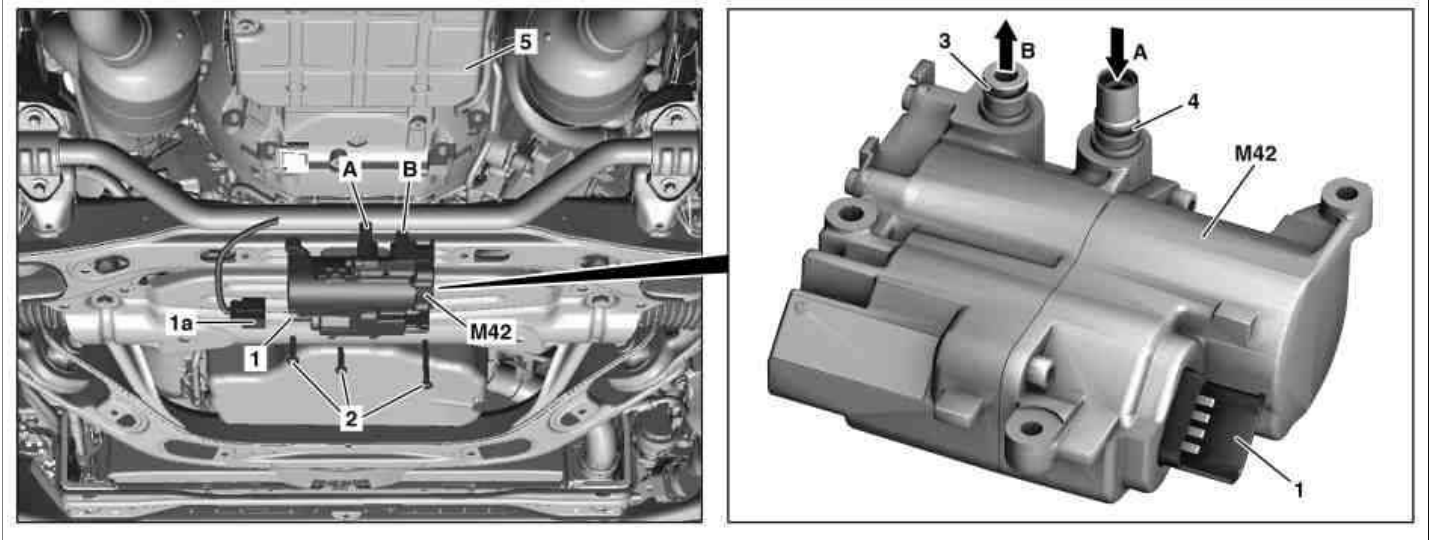
- 1 Electrical plug connection
- 1a Electrical connector
- 2 Screw

- 3 Oil guide pipe with sealing ring
- 4 Oil guide pipe with sealing ring
- 5 Transmission

- M42 Electric transmission oil pump
- A Intake side
- B Thrust side

☒ ☒	Remove/install		
		<p>ⓘ Before starting the work the area surrounding the connecting points on the transmission (5) must be thoroughly cleaned. Even the smallest dirt particles in the hydraulic components can lead to malfunctions and a total failure of the transmission (5).</p>

1.1	Remove bottom section of soundproofing	Vehicles with diesel engine Model 172 Model 212, 218	AR94.30-P-5300W AR94.30-P-5300EW
1.2	Remove engine compartment paneling	Vehicles with gasoline engine Model 172 Model 212, 218	AR61.20-P-1105W <b>AR61.20-P-1105EW</b>
2	Remove drain screw from transmission oil pan	<p>ⓘ Collect escaping ATF with drain pan. Note automatic transmission oil quantity.</p> <p>ⓘ It is <b>not</b> necessary to pry off the overflow pipe from the base of the transmission oil pan.</p> <p>Drain pan <a href="https://www.gotit.com/S/18.1_08.0">gotit://S 18.1 08.0</a></p>	
3	Detach electrical connector (1a) on electric transmission oil pump (M42)		
4	Detach electrical wiring harness from transmission (5) and set aside		
5	Remove screws (2) and detach electric transmission oil pump (M42)	<p>When reinstalling the electric transmission oil pump (M42): ↓</p> <p>☒ <b>Installation:</b> Check the oil guide pipe with sealing ring (3, 4) on the intake and pressure side (A, B) and replace if necessary.</p> <p>Nm</p>	*BA27.55-P-1009-01D

6	Install in the reverse order		
7	Fill transmission (5) with oil.	Vehicles without 4MATIC Vehicles with 4MATIC	AR27.00-P-0270W AR27.00-P-0270SYZ
☒	<b>Checking</b>
