2018 Mercedes Benz E63S AMG 4MATIC Sed (213.089) V8-4.0L Turbo (177.980)

## INDUCTIVE CHARGING: IPHONE IS NOT COMPLETELY CHARGED

Topic number	LI82.70-P-067429
Version	6
Function group	82.70 Telephone, Voice-control-system(VCS)
Date	01-13-2020
Validity	Model series 222, 213, 217, 238, and 257 with code 897, 898, and/or 899 up to and including code 800 (MY2020)
Reason for change	Information on anti-slip pad added to remedy.

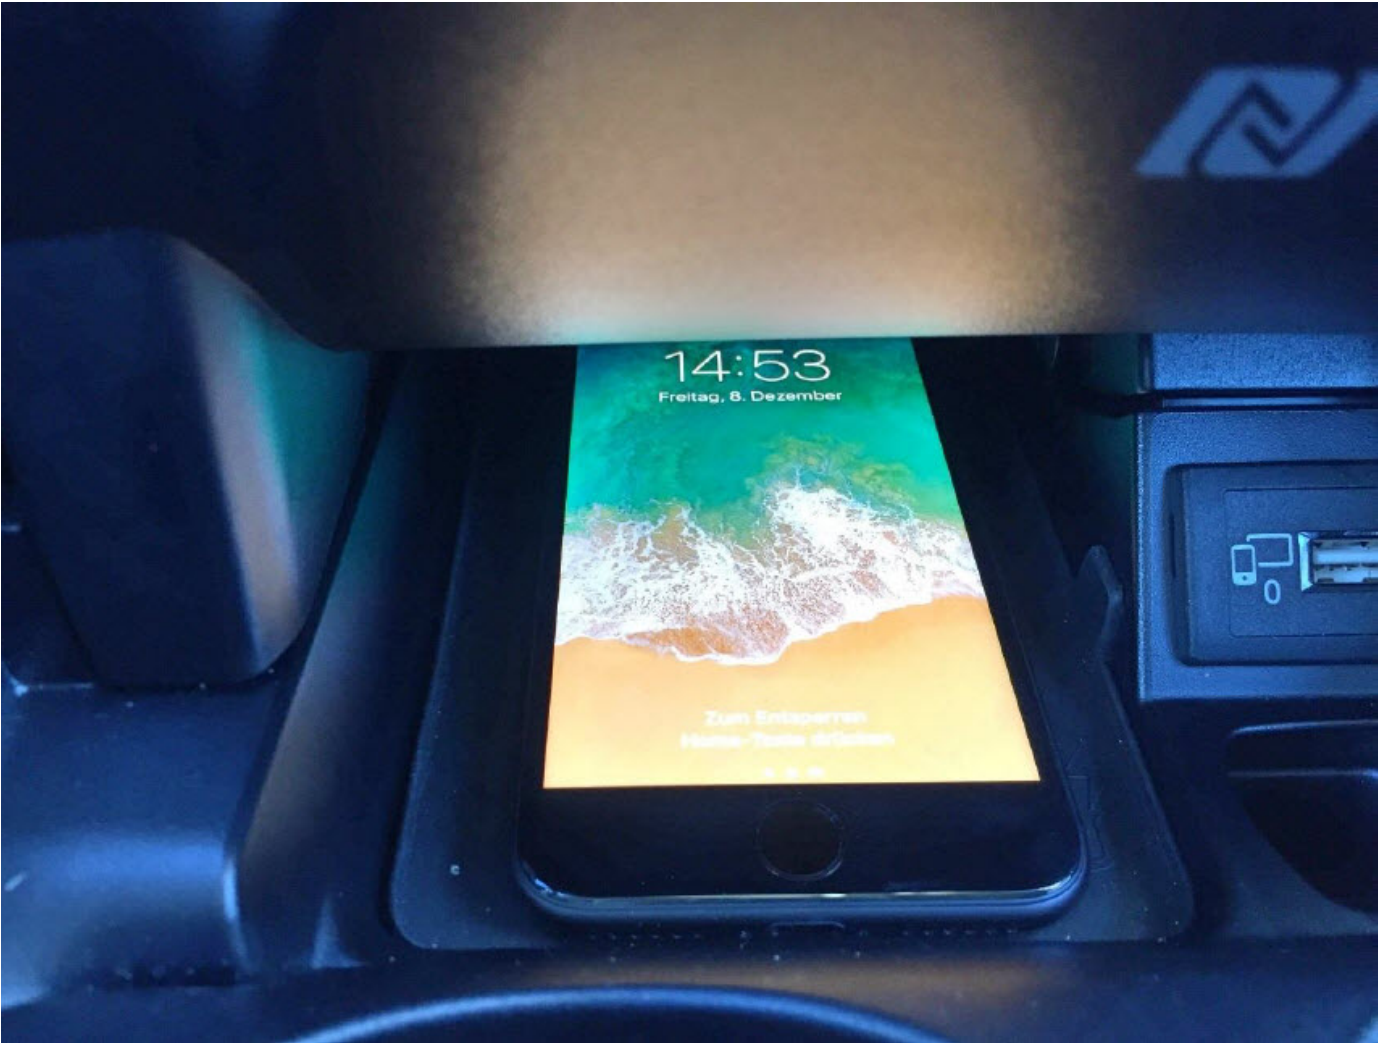
iPhone inductive charging position

If the iPhone is not optimally positioned in the mobile phone cradle, or has shifted during the journey, foreign object detection may be activated.

Note: The optimal charging position for the iPhone is the center of the mobile phone cradle (see attachment). In this position, the iPhone can be successfully charged by the inductive charger.

Optimal iPhone position in the inductive charging compartment

Perform software update of WMI control unit N123/8.

In addition, the customer can purchase an anti-slip pad for the iPhone 8, iPhone X and iPhone XS. This can help to further improve positioning of the iPhone.
