2018 Mercedes Benz E63S AMG 4MATIC Sed (213.089) V8-4.0L Turbo (177.980)

## CRACKS APPEAR ON TOUCHPAD SURFACE WITH NO SIGN OF EXTERNAL FORCE

Topic number	LI54.21-P-068464
Version	2
Function group	54.21 Control units / basic modules
Date	10-15-2020
Validity	Model series 166, 205, 213, 217, 222, 238, 253, 257, and 292 with code 448 prior to AJ19 / 1
Reason for change	Remedy updated

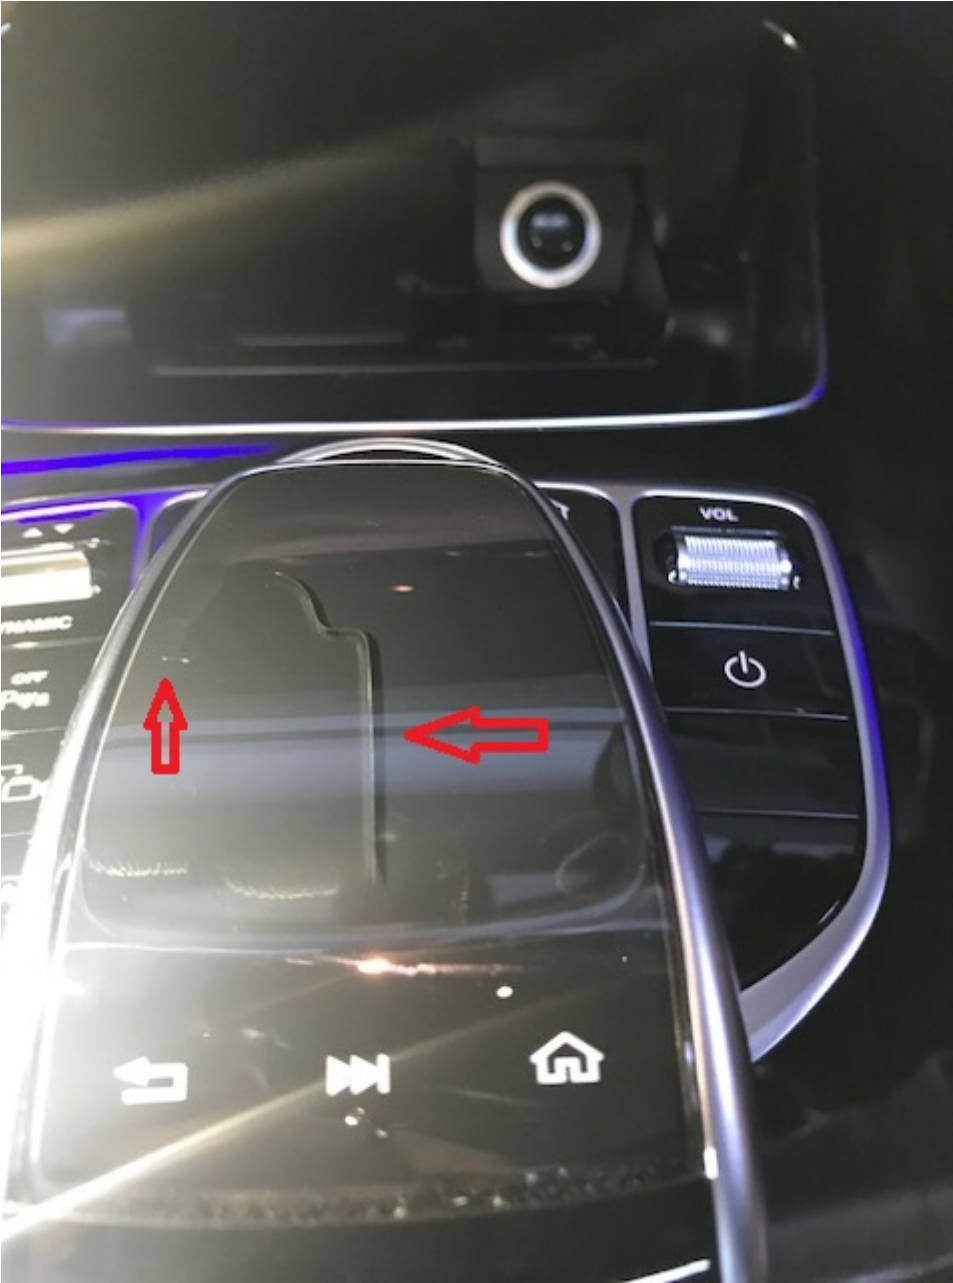
Cracks may occur on the surface of the touchpad without any application of external force (see attachments A and B). This problem mostly occurs at high ambient temperatures.

Internal stresses can develop inside the component which may result in cracks at high ambient temperatures.

Replace the Touchpad (A105).

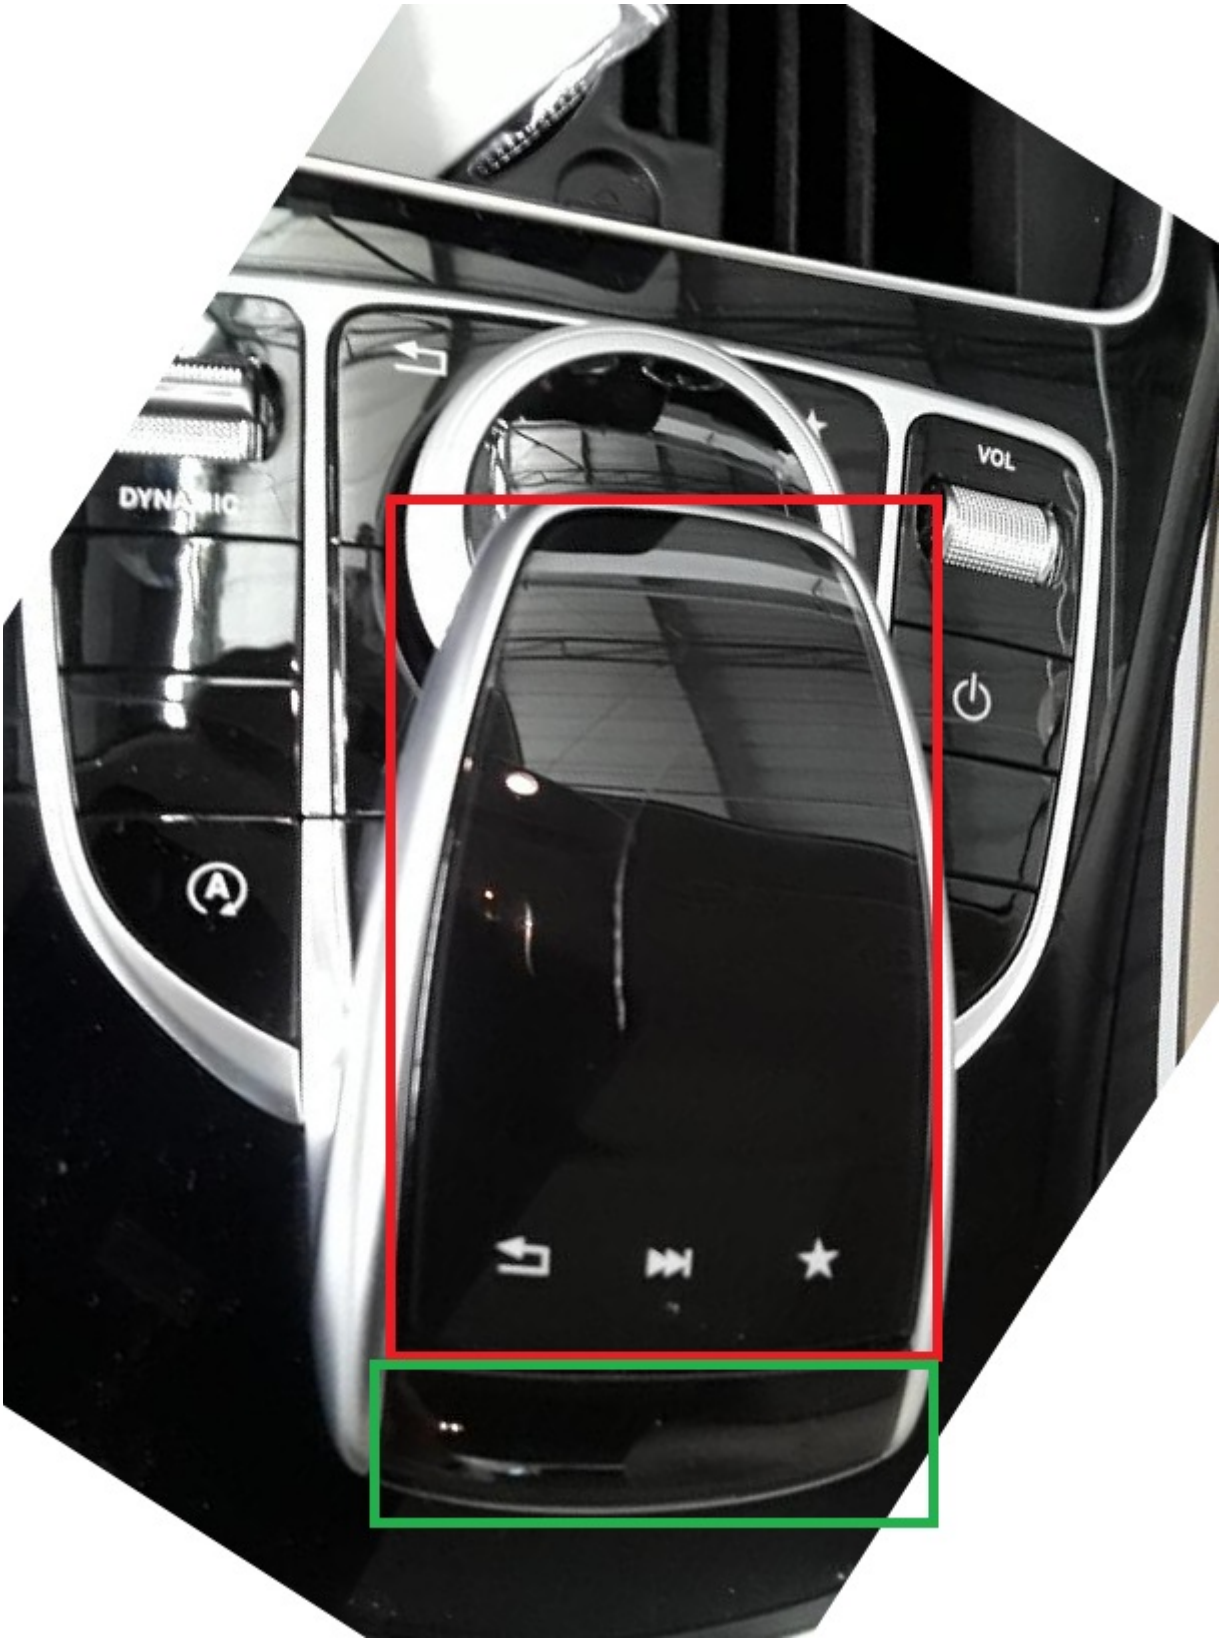
C

Note: See attachment C. The complaint does **not** affect the area outlined in green as it is manufactured using a different process

Touchpads installed in vehicles produced as of 01 June 2019 are manufactured using a different process and therefore are not subject to this complaint.
