2018 Mercedes Benz E63S AMG 4MATIC Sed (213.089) V8-4.0L Turbo (177.980)

## FRONT SEAT CUSHION COVER COMING OFF

Topic number	LI91.18-P-071313
Version	1
Function group	91.18 Seat covers
Date	07-20-2020
Validity	BR 213, 257, 290
Reason for change

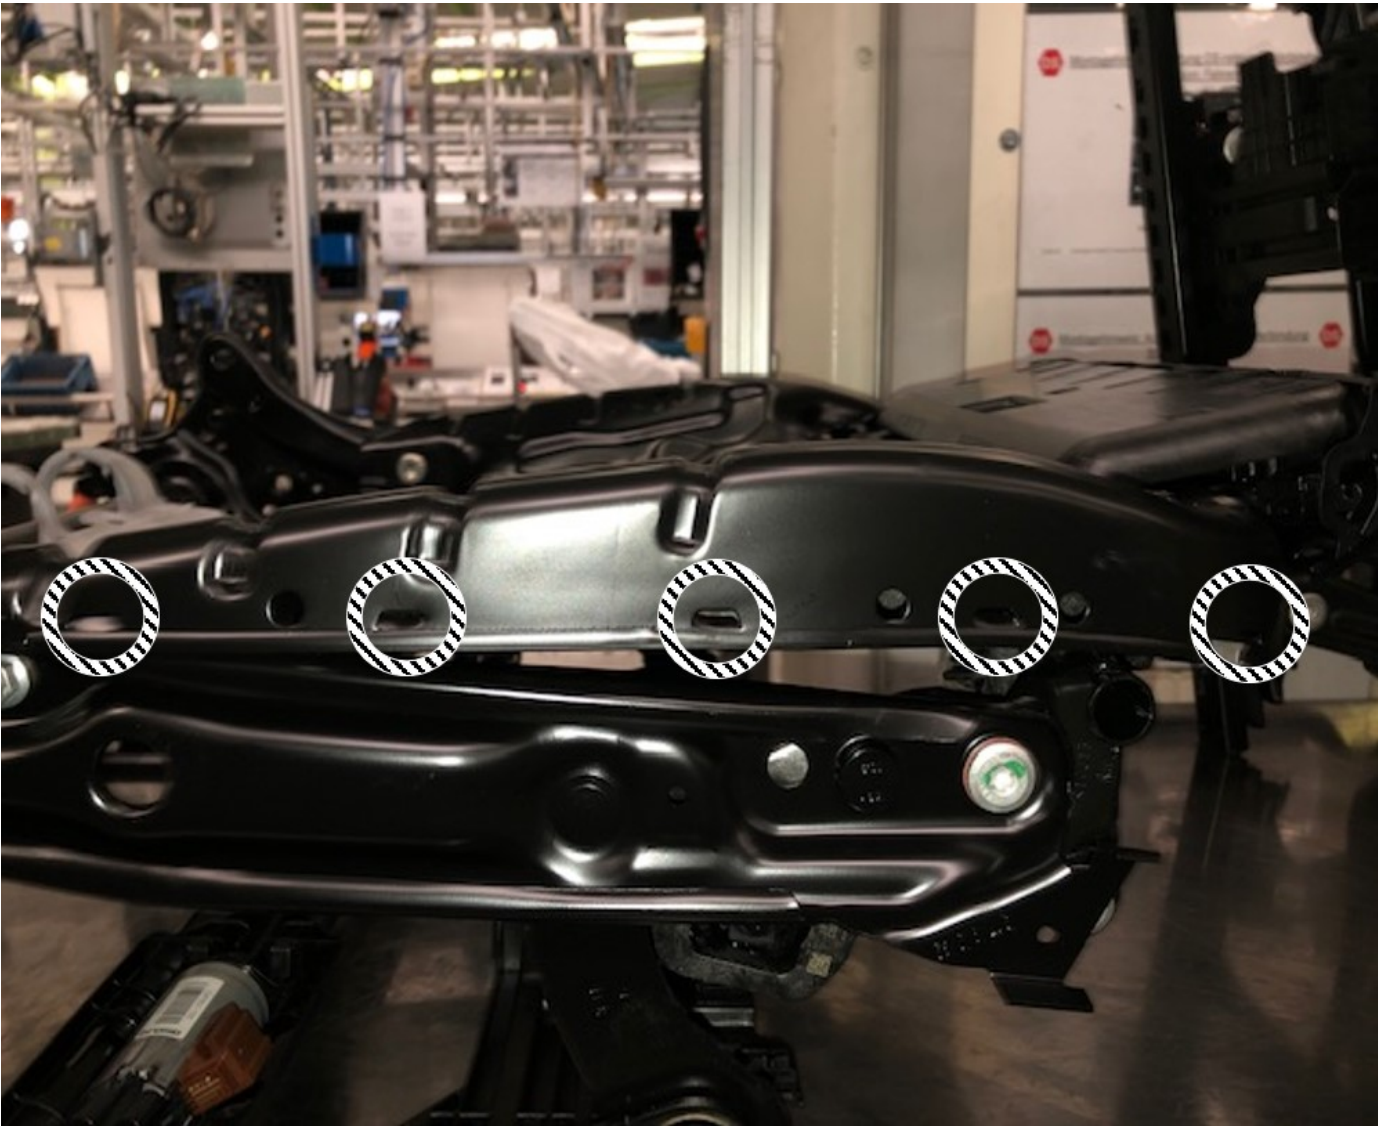
Bild 1

The fastening strip (profile) for the front seat cushion cover becomes detached from the side of the seat cushion frame.

Potentially insufficient holding ability of the fastening strip (profile).

Figure 1 Height adjuster

### 3. The side fastening hooks need to be bent up with pliers (5 x left & 5 x right - **Figure 1**)

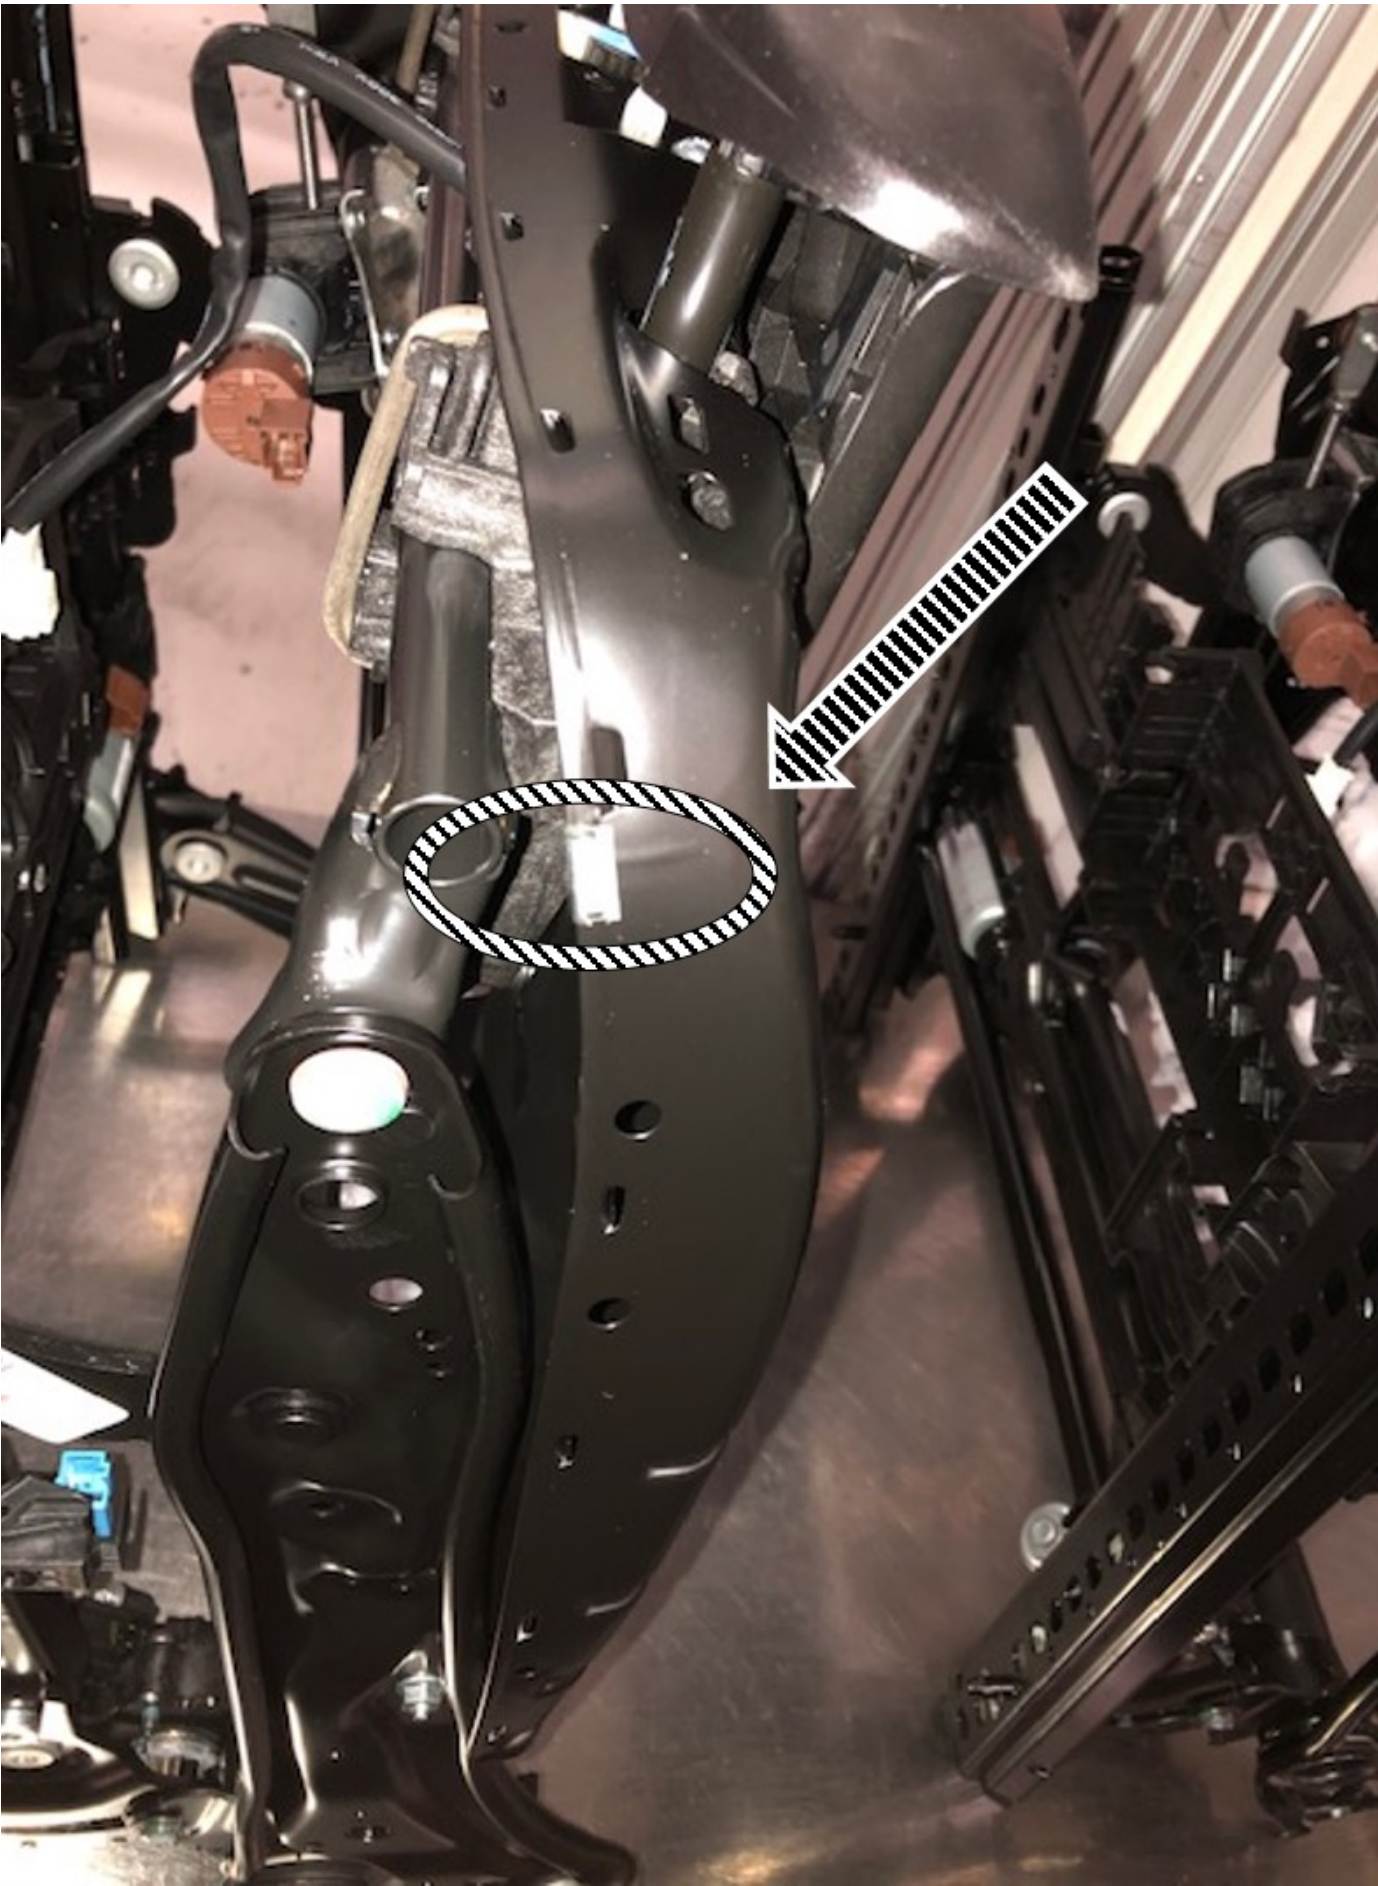
Bild 2

Figure 2 Height adjuster

### 4. For additional security, two spring clips (A 000 991 51 70) need to be attached to the height adjuster (for position, see **Figure 2**)

! Reattach the cover accurately and make sure that the fastener clicks firmly into place !
