2018 Mercedes Benz E63S AMG 4MATIC Sed (213.089) V8-4.0L Turbo (177.980)

SPLITTING OF SEAT COVERS

Topic number	LI91.10-P-063393
Version	4
Function group	91.10 Front seats
Date	05-03-2018
Validity	All Models
Reason for change	Remedy Adapted

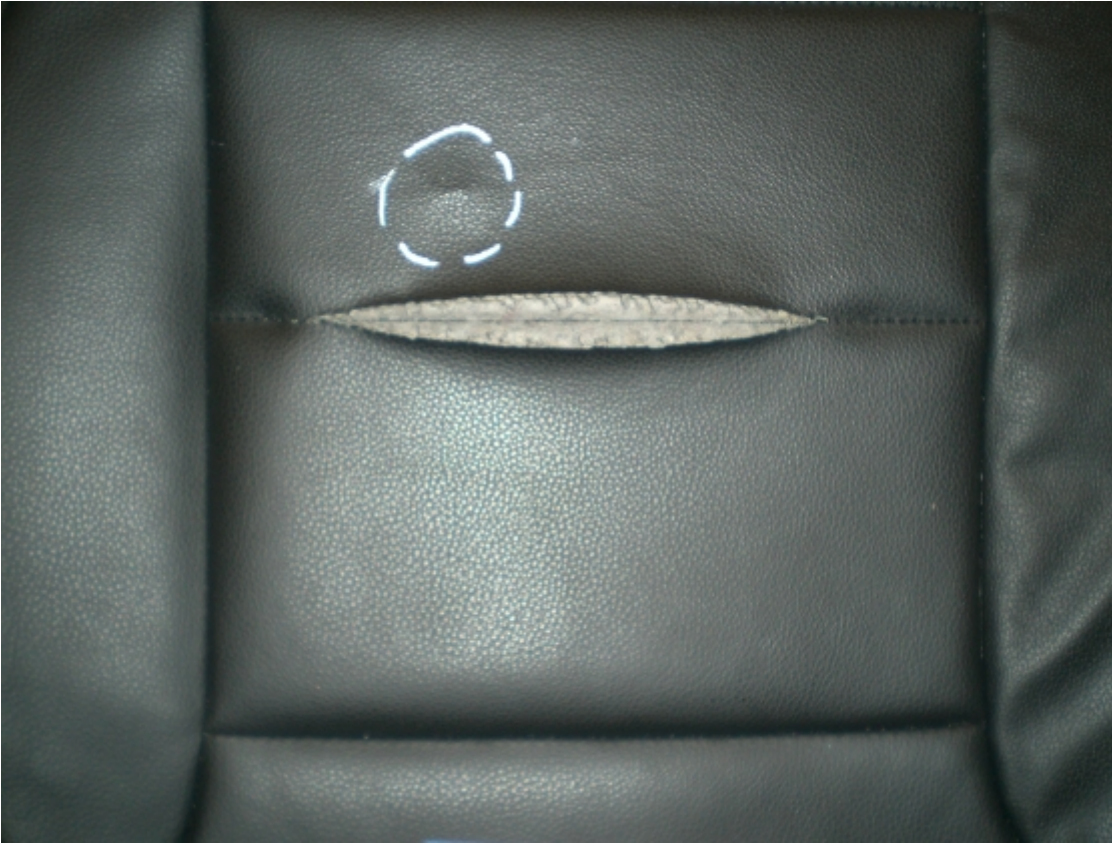
CIMG3870

Splitting of seat covers

Note: Please see pictures for examples of what above damages looks like.

File	Designation
CIMG3870.JPG.jpg	Splitting 3
CIMG3875.JPG.jpg	Splitting 2
CIMG3876.JPG.jpg	Splitting 1
Pictures.pdf	Splitting 4

Note: Please observe if outside influence such as improper cleaning agents or sharp cutting devices were the cause of splitting. This type of damage will not be covered under warranty. Please reference WIS document AP68.00- P-1000ZZ for proper cleaning instructions.

Replace Seat Covers as needed.
